## General Information

| Make | Toyota | Model | Corolla Altis |
| YOM | 2006 | Mileage | 369,516 |
| Registration No. | ZCK228 | Chassis No. | ZZE1218017197 |

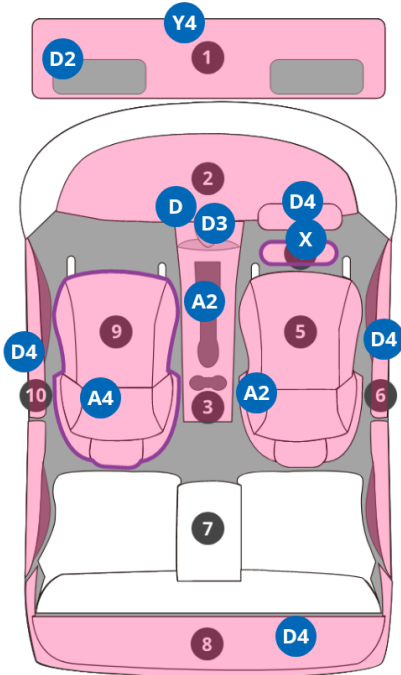
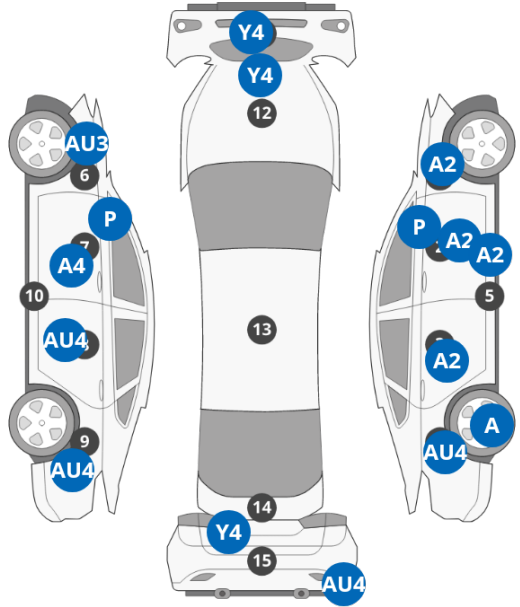
| Interior Evaluation : <b>E</b> | Exterior Evaluation : <b>E</b> |
|---|---|
| <p><b>Remarks</b></p> <p>Overall Interior - Worn as per age - Yes / Mat Other - Missing - Yes / Dashboard - Loose, Deformed - Large / (R) Front Seat - Cut, Crack - Small / (L) Front Seat - Cut, Crack - Large / (L) Front Seat Knobs - Partially Missing - Yes / Console, Switchs, Vents - Loose, Deformed - Medium / Dashboard - Traces of Adhesive Tape - Yes / Trunk Room - Loose, Deformed - Large / Knobs - Worn, Peel, Crack - Small / (L) Front Trim - Worked - Large / (R) Front Trim - Worked - Large / Sunvisor, Sunglass Holder - Loose, Deformed - Small / Ceiling - Grime - Large</p> | <p><b>Remarks</b></p> <p>(R) Front Door - Repair Traces - Yes / (R) Front Fender - Repair Traces - Yes / Bonnet - Repair Traces - Yes / (L) Front Fender - Repair Traces - Yes / (L) Front Door - Repair Traces - Yes / (L) Rear Door - Repair Traces - Yes / (L) Rear Fender - Repair Traces - Yes / (R) Rear Door - Repair Traces - Yes / Roof - Repair Traces - Yes / (R) Rear Fender, Molding - Scratch &amp; Dent - Large / Rear Bumper, Lamps, Panels - Scratch &amp; Dent - Large / Overall Exterior - Faded(Color, Gloss) - Yes / (R) Rear Tyre - Crack, Cut - Yes / (R) Rear Door, Molding - Scratch - Small / (R) Front Door, Molding - Scratch - Small / (R) Step, In-panel, Side Spoiler - Scratch - Small / (R) Front Fender, Molding - Scratch - Small / (R) Mirror - Faded(Color, Gloss) - Yes / Front Bumper, Grille, Lamps - Crack, Gap - Large / Bonnet, Headlight - Crack, Gap - Large / (L) Front Fender, Molding - Scratch &amp; Dent - Medium / (L) Mirror - Faded(Color, Gloss) - Yes / (L) Front Door, Molding - Scratch - Large / (L) Rear Door, Molding - Scratch &amp; Dent - Large / (L) Rear Fender, Molding - Scratch &amp; Dent - Large / Trunk Hood, Rear Gate - Crack, Gap - Large</p> |

| Inspector Notes |
|---|
| no warranty booklet/ no tools / with jack and spare tire/ power window issue/ plate light issue/ front. fender turn signals not working/ wiper issue / aircon issue/ panel meter issue/ flat tire/ |
