## General Information

| Make | Toyota | Model | Vios |

## Body / Panel Condition

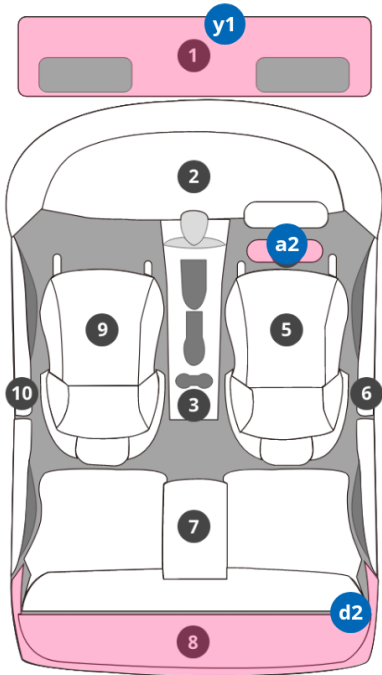
| Interior Evaluation : <span style="color: red; font-weight: bold;">A</span> | | Exterior Evaluation : <span style="color: red; font-weight: bold;">B</span> | |
| <p><b>Remarks</b></p> <p>(L) Front Floor Lag - Cut, Crack - Small / Trunk Room - Loose, Deformed, Grime - Small / Ceiling - Grime - Minimal</p> | | <p><b>Remarks</b></p> <p>(R) Step - Repair Traces - Yes / (R) Front Fender, Molding - Dent - Minimal / Front Bumper, Grille, Lamps - Scratch - Small / (L) Front Fender, Molding - Scratch &amp; Dent - Minimal / (L) Front Door, Molding - Scratch - Minimal / (L) Rear Fender, Molding - Scratch - Medium / Rear Bumper, Lamps, Panels - Scratch - Minimal / (R) Rear Fender, Molding - Scratch - Minimal / (R) Rear Door, Molding - Scratch - Minimal / (R) Front Door, Molding - Scratch - Minimal / (R) Mirror - Scratch - Small</p> | |

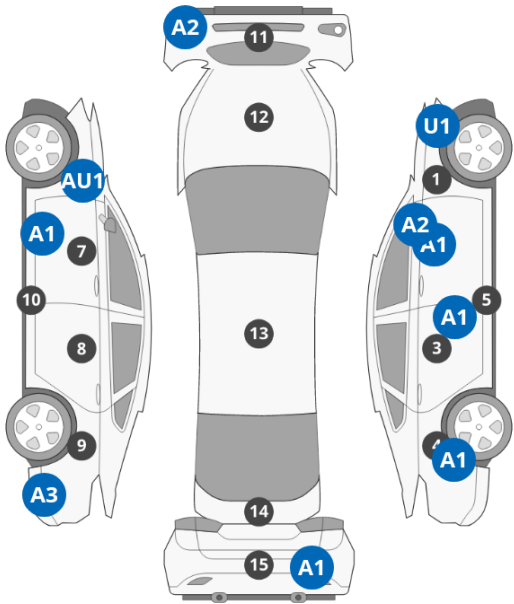
more light scratches around the exterior.
