## General Information

| Make | Toyota | Model | Vios |

## Body / Panel Condition

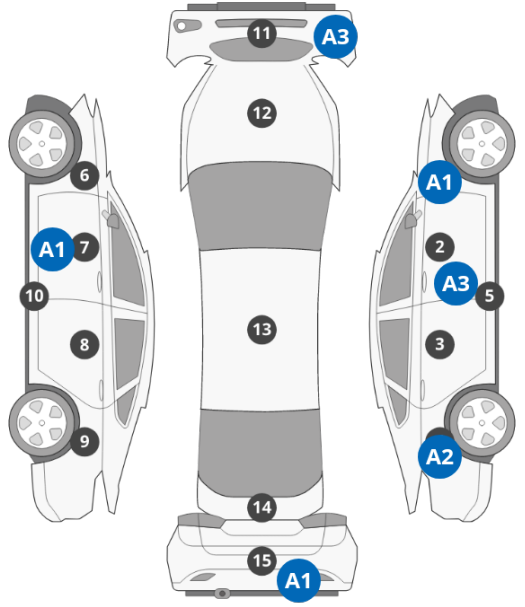
| Interior Evaluation : <span style="color: red; font-weight: bold;">A</span> | Exterior Evaluation : <span style="color: red; font-weight: bold;">B</span> |
| <b>Remarks</b><br>Defects not found | <b>Remarks</b><br>(R) Front Fender, Molding - Scratch - Minimal / Front Bumper, Grille, Lamps - Scratch - Medium / (L) Front Door, Molding - Scratch - Minimal / (R) Rear Fender, Molding - Scratch - Small / Rear Bumper, Lamps, Panels - Scratch - Minimal / (R) Front Door, Molding - Scratch - Medium |

more light scratches around the exterior. rear matting has molds.
