General Information

Make	Toyota	Model	Vios
YOM	2024	Odo Meter Reading	11,105
Registration No.	NKB8799	Chassis No.	PA1B18F33R4250462
CC	1.3	Transmission	CVT
Fuel Type	Gas	Type of Body	Sedan
Colour	Blue

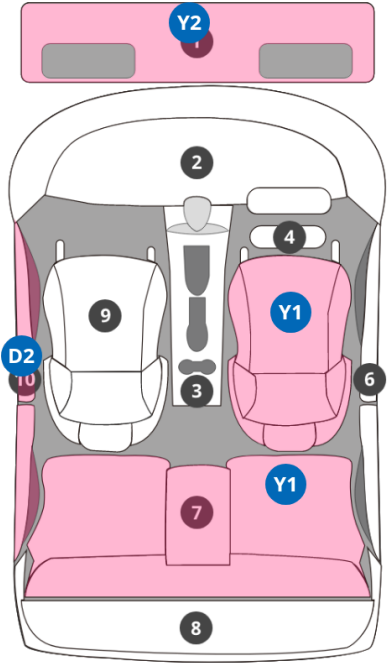
<p>a : Cut, Fray d : Loose, Deformed k : Animal Hair s : Smell t : Cigarette Burns x : Defective y : Stain</p>

<p>A : Scratch AU : Scratch & Dent B : Modified C : Corrosion G : Stone chip P : Faded S : Rust SC : Rust & Corrosion U : Dent X : Defective Y : Crack, Gap</p>
<p>Remarks Rear Seat - Grime - Minimal / (L) Front Trim - Worked - Small / (R) Front Seat - Grime - Minimal / Ceiling - Grime - Small</p>	<p>Remarks (R) Front Fender, Molding - Scratch - Small / (R) Front Door, Molding - Scratch - Minimal / (R) Mirror - Scratch - Minimal / (R) Rear Door, Molding - Scratch - Minimal / (R) Rear Fender, Molding - Scratch - Minimal / Rear Bumper, Lamps, Panels - Scratch - Large / Trunk Hood, Rear Gate - Scratch - Minimal / Roof - Scratch - Small / (L) Rear Fender, Molding - Scratch - Minimal / (L) Rear Door, Molding - Scratch - Minimal / (L) Front Door, Molding - Scratch - Minimal / (L) Front Fender, Molding - Scratch - Minimal / Front Bumper, Grille, Lamps - Scratch - Minimal / Bonnet, Headlight - Scratch - Minimal</p>
