## General Information

<b>Make</b>	Toyota	<b>Model</b>	Vios
<b>YOM</b>	2024	<b>Odo Meter Reading</b>	4,229
<b>Registration No.</b>	VAB9741	<b>Chassis No.</b>	PA1B18F639R4258033
<b>CC</b>	1.3	<b>Transmission</b>	CVT
<b>Fuel Type</b>	Gas	<b>Type of Body</b>	Sedan
<b>Colour</b>	Red

## Body / Panel Condition

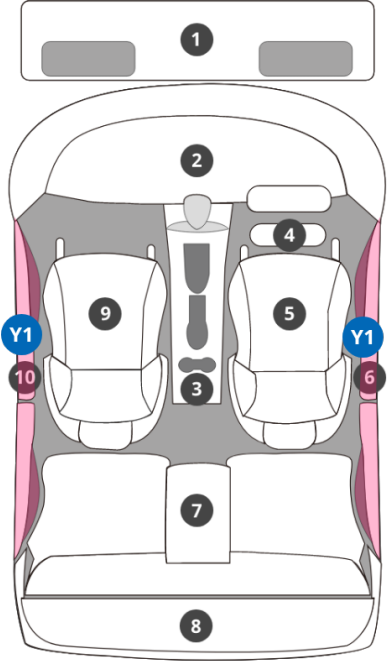
<b>Interior Evaluation :</b> <span style="float: right; color: red; font-weight: bold;">A</span>	<b>Exterior Evaluation :</b> <span style="float: right; color: red; font-weight: bold;">A</span>

<p><b>a</b> : Cut, Fray <b>d</b> : Loose, Deformed <b>k</b> : Animal Hair <b>s</b> : Smell <b>t</b> : Cigarette Burns <b>x</b> : Defective <b>y</b> : Stain</p>

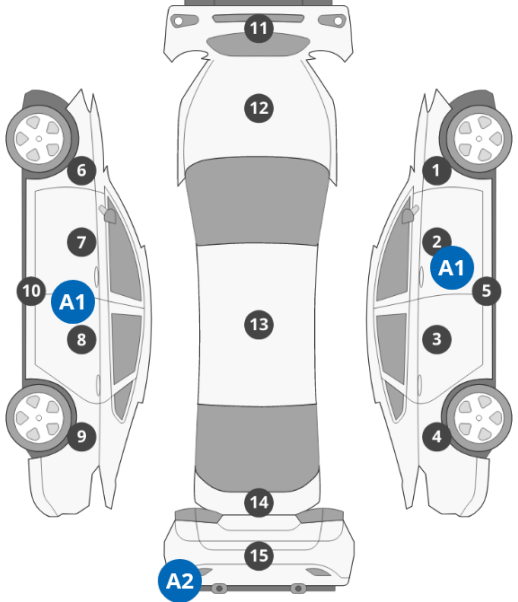
<p><b>A</b> : Scratch <b>AU</b> : Scratch &amp; Dent <b>B</b> : Modified <b>C</b> : Corrosion <b>G</b> : Stone chip <b>P</b> : Faded <b>S</b> : Rust <b>SC</b> : Rust &amp; Corrosion <b>U</b> : Dent <b>X</b> : Defective <b>Y</b> : Crack, Gap</p>
<p><b>Remarks</b> (R) Front Trim - Grime - Minimal / (L) Front Trim - Grime - Minimal</p>	<p><b>Remarks</b> (R) Front Door, Molding - Scratch - Minimal / Rear Bumper, Lamps, Panels - Scratch - Small / (L) Rear Door, Molding - Scratch - Minimal</p>
<b>Frame Evaluation :</b> <span style="float: right; color: red; font-weight: bold;">A</span>	<b>Functional Evaluation :</b> <span style="float: right; color: red; font-weight: bold;">C</span>
