## General Information

| Make | Toyota | Model | Vios |

## Body / Panel Condition

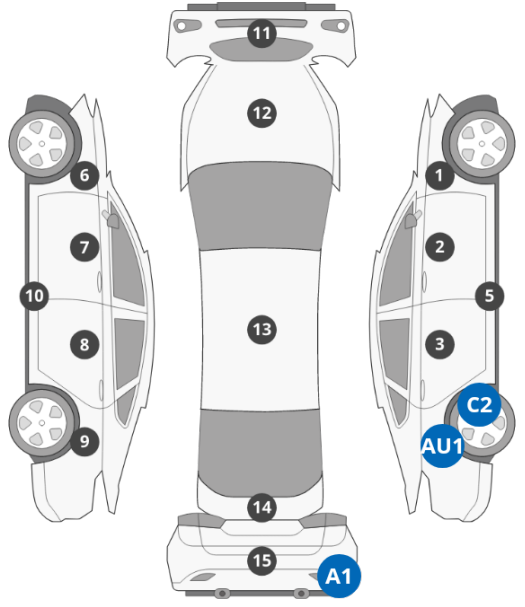
| Interior Evaluation : <span style="color: red; font-weight: bold;">A</span> | Exterior Evaluation : <span style="color: red; font-weight: bold;">A</span> |
| <b>Remarks</b><br>Defects not found | <b>Remarks</b><br>(R) Rear Fender, Molding - Scratch & Dent - Minimal / Rear Bumper, Lamps, Panels - Scratch - Minimal / (R) Rear Wheel, Cover - Scratch, Corrosion - Small |

| Inspector Notes |
|---|
| hairline scratches and swirl marks |
