General Information

Make	Toyota	Model	Vios
YOM	2023	Mileage	31,258
Registration No.	NIH6448	Chassis No.	PA1B18F35P4200756
CC	1.3	Transmission	CVT
Fuel Type	Gas	Type of Body	Sedan
Colour	Red Mica Metallic

Body / Panel Condition

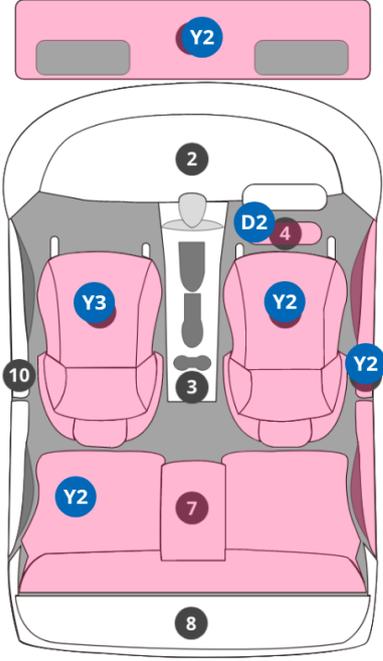
Interior Evaluation : B	Exterior Evaluation : C

<p>a : Cut, Fray d : Loose, Deformed k : Animal Hair s : Smell t : Cigarette Burns x : Defective y : Stain</p>

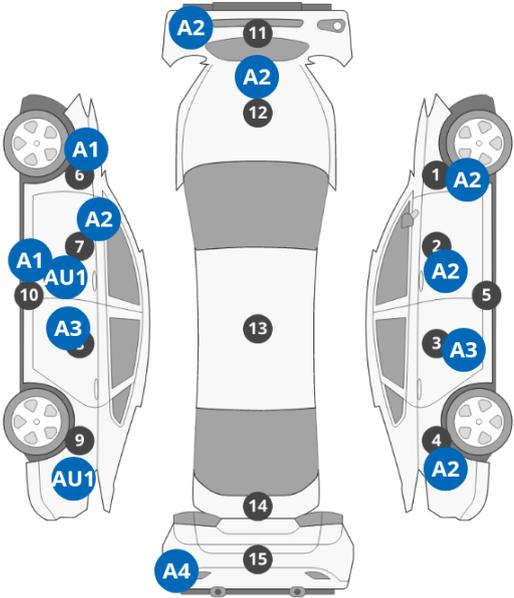
<p>A : Scratch AU : Scratch & Dent B : Modified C : Corrosion G : Stone chip P : Faded S : Rust SC : Rust & Corrosion U : Dent X : Defective Y : Crack, Gap</p>
<p>Remarks (R) Front Seat - Grime - Small / (R) Front Trim - Grime - Small / Ceiling - Grime - Small / Rear Seat - Grime - Small / (L) Front Seat - Grime - Medium / (L) Front Floor Mat - Worked - Small</p>	<p>Remarks (L) Rear Fender, Molding - Scratch & Dent - Minimal / (L) Front Door, Molding - Scratch & Dent - Minimal / (L) Mirror - Scratch - Small / (L) Front Fender, Molding - Scratch - Minimal / (R) Rear Fender, Molding - Scratch - Small / (R) Rear Door, Molding - Scratch - Medium / (R) Front Door, Molding - Scratch - Small / (R) Front Fender, Molding - Scratch - Small / Bonnet, Headlight - Scratch - Small / (L) Step, In-panel, Side Spoiler - Scratch - Minimal / Rear Bumper, Lamps, Panels - Scratch - Large / Front Bumper, Grille, Lamps - Scratch - Small / (L) Rear Door, Molding - Scratch - Medium</p>
