General Information

Make	Mitsubishi	Model	Mirage
YOM	2019	Mileage	46,559
Registration No.	NFU9910	Chassis No.	PAEA13TXKKA009811
CC	1.2	Transmission	A/T
Fuel Type	Gas	Type of Body	Sedan
Colour	Blue

Body / Panel Condition

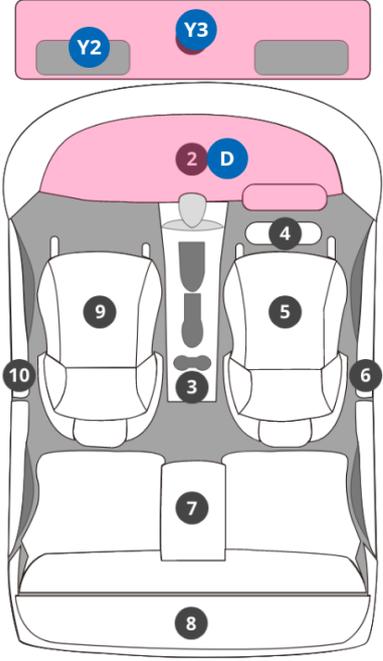
Interior Evaluation : B	Exterior Evaluation : E

<p>a : Cut, Fray d : Loose, Deformed k : Animal Hair s : Smell t : Cigarette Burns x : Defective y : Stain</p>

<p>A : Scratch AU : Scratch & Dent B : Modified C : Corrosion G : Stone chip P : Faded S : Rust SC : Rust & Corrosion U : Dent X : Defective Y : Crack, Gap</p>
<p>Remarks Ceiling - Grime - Medium / Dashboard - Traces of Adhesive Tape - Yes / Sunvisor, Sunglass Holder - Grime - Small</p>	<p>Remarks (R) Front Door - Repair Traces - Yes / (R) Front Fender - Repair Traces - Yes / Bonnet - Repair Traces - Yes / (L) Front Fender - Repair Traces - Yes / (R) Rear Door - Repair Traces - Yes / Roof - Repair Traces - Yes / (L) Front Fender, Molding - Dent - Medium / (L) Rear Door, Molding - Scratch & Dent - Large / (L) Rear Fender, Molding - Scratch & Dent - Small / (L) Front Door, Molding - Scratch - Small / (L) Mirror - Scratch - Minimal / Rear Bumper, Lamps, Panels - Scratch & Dent - Large / (R) Rear Door, Molding - Scratch - Small / (R) Front Fender, Molding - Scratch & Dent - Medium / (R) Step, In-panel, Side Spoiler - Scratch & Dent - Small / Trunk Hood, Rear Gate - Dent - Small / Front Bumper, Grille, Lamps - Scratch & Dent - Large / Member (Bolted) - Dent - Yes / (R) Mirror - Scratch - Small</p>

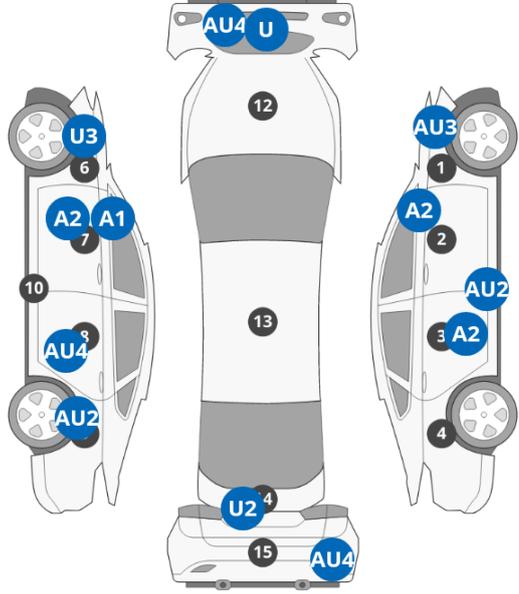
<p>Inspector Notes</p>
<p>Without warranty booklet, jack and tools. With spare tire and seat cover. 1 key. Gap at front and rear bumper. small crack at headlight. With LTO plate.</p>
