General Information

Make	Toyota	Model	Vios
YOM	2024	Odo Meter Reading	27,037
Registration No.	CCD4156	Chassis No.	PA1B18F38R4256757
CC	1.3	Transmission	CVT
Fuel Type	Gas	Type of Body	Sedan
Colour	Silver

Body / Panel Condition

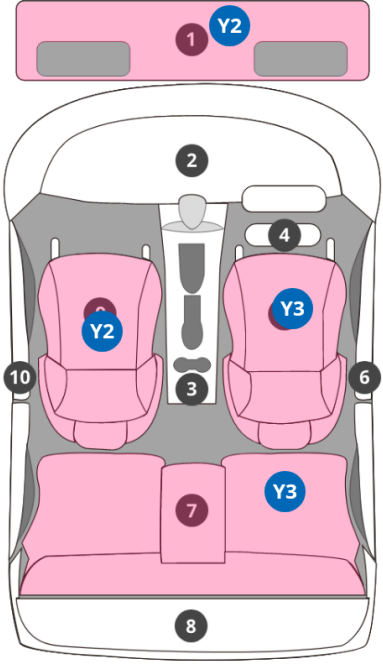
Interior Evaluation : B	Exterior Evaluation : C

<p>A : Scratch AU : Scratch & Dent B : Modified C : Corrosion G : Stone chip P : Faded S : Rust SC : Rust & Corrosion U : Dent X : Defective Y : Crack, Gap</p>
<p>Remarks Ceiling - Grime - Small / (L) Front Seat - Grime - Small / Rear Seat - Grime - Medium / (R) Front Seat - Grime - Medium</p>	<p>Remarks (L) Front Door, Molding - Scratch - Large / (L) Rear Door, Molding - Scratch - Large / Trunk Hood, Rear Gate - Scratch - Medium / Front Bumper, Grille, Lamps - Scratch - Medium</p>
Frame Evaluation : A	Functional Evaluation : B
<p>Remarks Defects not found</p>	<p>Remarks Battery - Weak - Yes</p>

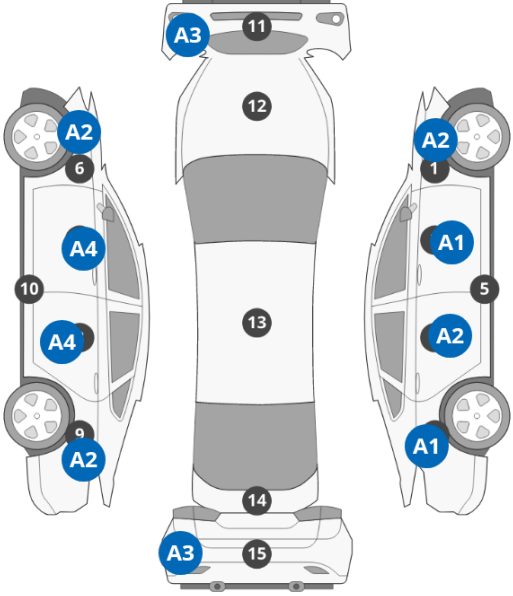
<p>Inspector Notes</p>
<p>With LTO plate and sparetire, Incomplete tools. no warranty booklet and jack. crack tail light and scratch.</p>
