## General Information

| Make | Toyota | Model | Vios |
| Registration No. | DBM4591 | Chassis No. | PA1B18F30R4241704 |

## Body / Panel Condition

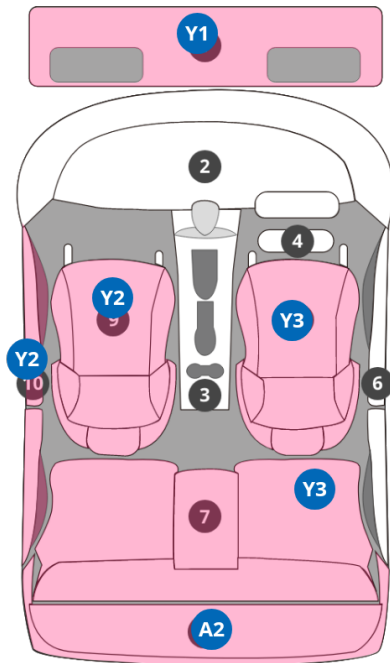
| Interior Evaluation : <b>B</b> | Exterior Evaluation : <b>C</b> |
|---|---|
| <b>Remarks</b><br>Trunk Room - Worn, Scratch, Cut, Crack - Small / Rear Seat - Grime - Medium / (R) Front Seat - Grime - Medium / (L) Front Seat - Grime - Small / Ceiling - Grime - Minimal / (L) Front Trim - Grime - Small | <b>Remarks</b><br>(R) Front Door - Repair Traces - Yes / (R) Front Fender, Molding - Scratch - Minimal / (R) Front Door, Molding - Repair mark - Yes / (R) Front Door, Molding - Scratch - Minimal / (R) Mirror - Scratch - Small / (R) Rear Door, Molding - Scratch - Minimal / (R) Rear Fender, Molding - Scratch - Minimal / Rear Bumper, Lamps, Panels - Scratch - Medium / Trunk Hood, Rear Gate - Scratch & Dent - Small / (L) Rear Fender, Molding - Scratch - Small / (L) Rear Door, Molding - Scratch - Minimal / (L) Mirror - Scratch - Small / (L) Front Fender, Molding - Scratch - Minimal / Front Bumper, Grille, Lamps - Repair mark - Yes / Bonnet, Headlight - Scratch - Minimal |
