## General Information

| Make | Toyota | Model | Innova |
| Registration No. | DBO1307 | Chassis No. | PA2JA8EM8P0133157 |

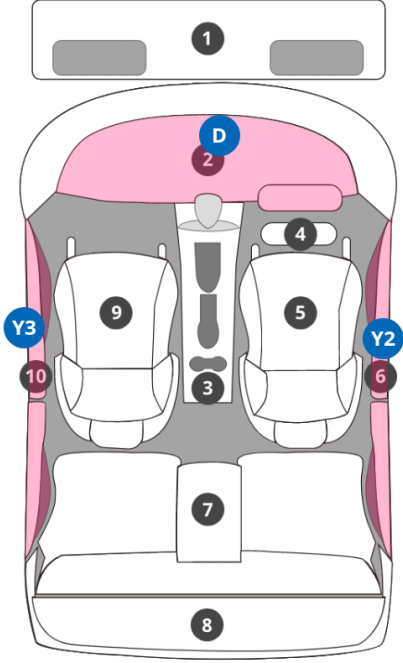
| <b>Remarks</b><br>(L) Front Trim - Grime - Medium / (R) Front Trim - Grime - Small / Dashboard - Traces of Adhesive Tape - Yes | <b>Remarks</b><br>(L) Front Fender - Repair Traces - Yes / (R) Mirror - Scratch - Small / (R) Front Door, Molding - Dent - Medium / (R) Rear Fender, Molding - Dent - Minimal / (R) Rear Door, Molding - Scratch - Small / Rear Bumper, Lamps, Panels - Scratch & Dent - Small / Trunk Hood, Rear Gate - Scratch - Small / (L) Rear Fender, Molding - Scratch - Small / (L) Mirror - Scratch - Minimal / (L) Rear Door, Molding - Scratch - Small / (L) Front Door, Molding - Scratch & Dent - Small / (L) Step, In-panel, Side Spoiler - Scratch - Minimal / (L) Front Fender, Molding - Dent - Minimal / Front Bumper, Grille, Lamps - Crack, Gap - Medium / Bonnet, Headlight - Scratch - Minimal |
