## General Information

| Make | Toyota | Model | Vios |
| YOM | 2024 | Mileage | 19,147 |

## Body / Panel Condition

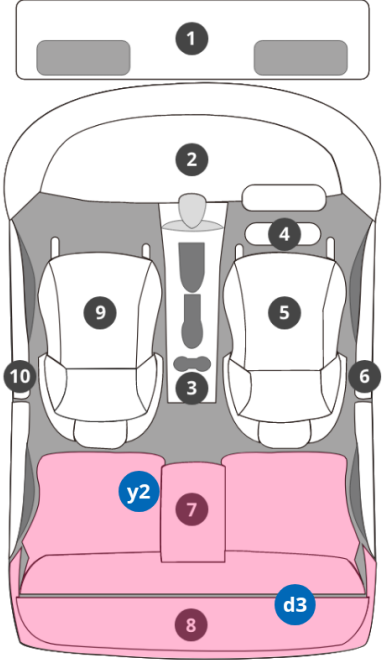
| <b>Remarks</b><br>Rear Seat - Grime - Small / Trunk Room - Loose, Deformed, Grime - Medium | <b>Remarks</b><br>Trunk Hood, Rear Gate - Scratch & Dent - Medium / Rear Bumper, Lamps, Panels - Scratch & Dent - Medium / (R) Rear Fender, Molding - Scratch & Dent - Small / Front Bumper, Grille, Lamps - Scratch - Small / (L) Front Door, Molding - Scratch - Minimal / Bonnet, Headlight - Scratch - Minimal / (R) Mirror - Scratch - Minimal / (R) Rear Door, Molding - Scratch - Minimal / (R) Front Door, Molding - Scratch - Small / (L) Mirror - Scratch - Minimal |

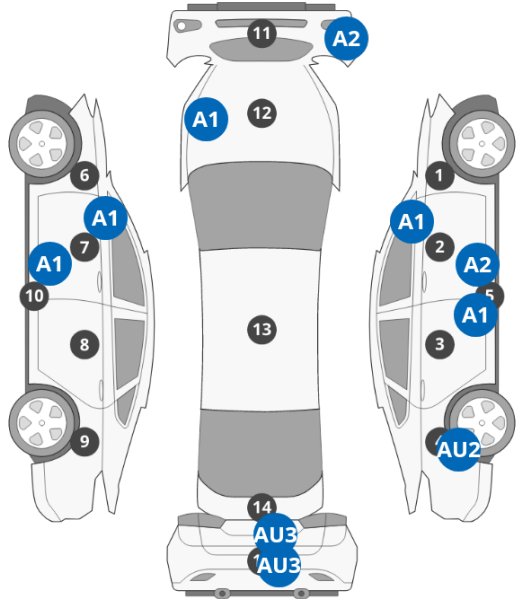
| Inspector Notes |
|---|
| light scratches around the exterior. more scratch and dent at the trunk door. |
