General Information

Make	Toyota	Model	Vios
YOM	2021	Mileage	47,816
Registration No.	NDZ5584	Chassis No.	PA1B18F36M4138411
CC	1.3	Transmission	A/T
Fuel Type	Gas	Type of Body	Sedan
Colour	Blue

Body / Panel Condition

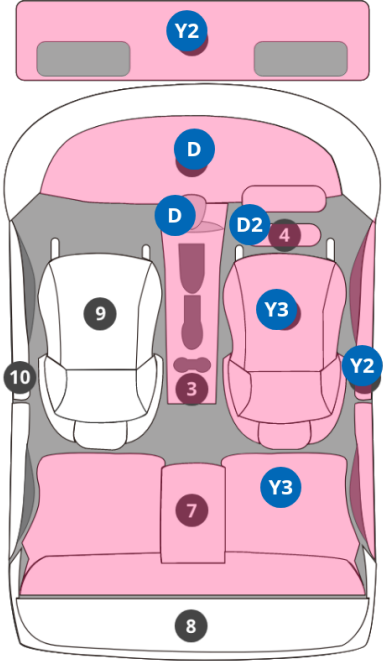
Interior Evaluation : B	Exterior Evaluation : C

<p>a : Cut, Fray d : Loose, Deformed k : Animal Hair s : Smell t : Cigarette Burns x : Defective y : Stain</p>

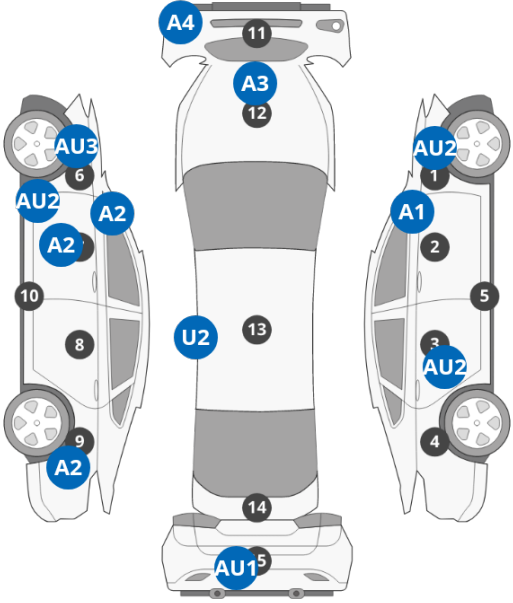
<p>A : Scratch AU : Scratch & Dent B : Modified C : Corrosion G : Stone chip P : Faded S : Rust SC : Rust & Corrosion U : Dent X : Defective Y : Crack, Gap</p>
<p>Remarks (R) Front Seat - Grime - Medium / Dashboard - Traces of Adhesive Tape - Yes / (R) Front Trim - Grime - Small / Rear Seat - Grime - Medium / (L) Front Floor Mat - Worked - Small / Ceiling - Grime - Small / Console, Switches, Vents - Traces of Adhesive Tape - Yes</p>	<p>Remarks (R) Front Door - Repair Traces - Yes / (L) Front Fender - Repair Traces - Yes / (L) Front Door - Repair Traces - Yes / (L) Step - Repair Traces - Yes / (L) Rear Door - Repair Traces - Yes / (L) Rear Fender - Repair Traces - Yes / (R) Rear Fender - Repair Traces - Yes / Roof - Repair Traces - Yes / (R) Rear Door, Molding - Scratch & Dent - Small / (R) Mirror - Scratch - Minimal / (L) Front Fender, Molding - Scratch & Dent - Medium / Front Bumper, Grille, Lamps - Scratch - Large / (L) Mirror - Scratch - Small / (L) Front Door, Molding - Scratch - Small / Roof - Dent - Small / (L) Rear Fender, Molding - Scratch - Small / (L) Step, In-panel, Side Spoiler - Scratch & Dent - Small / Rear Bumper, Lamps, Panels - Scratch & Dent - Minimal / (R) Front Fender, Molding - Scratch & Dent - Small / Bonnet, Headlight - Scratch - Medium</p>
