## General Information

| Make | Toyota | Model | Hiace |
| YOM | 2020 | Mileage | 65,192 |
| Registration No. | NEU5948 | Chassis No. | JTFJT02P6K0013822 |

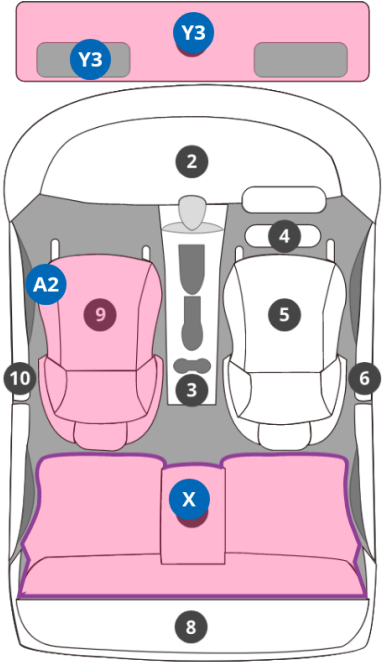
| Interior Evaluation : <b>C</b> | Exterior Evaluation : <b>D</b> |
| <p><b>Remarks</b><br/>Ceiling - Grime - Medium / Rear Seat - Partially Missing - Yes / Sunvisor, Sunglass Holder - Grime - Medium / (L) Front Seat - Cut, Crack - Small</p> | <p><b>Remarks</b><br/>(R) Rear Door - Repair Traces - Yes / (L) Mirror - Scratch - Small / (R) Mirror - Scratch - Small / (R) Front Door, Molding - Scratch - Medium / Front Bumper, Grille, Lamps - Scratch &amp; Dent - Medium / (R) Rear Door, Molding - Scratch - Large / (L) Rear Door, Molding - Scratch - Medium / Roof - Scratch &amp; Dent - Medium / Trunk Hood, Rear Gate - Scratch &amp; Dent - Medium / Rear Bumper, Lamps, Panels - Scratch - Medium</p> |
