## General Information

| Make | Honda | Model | BR-V |
| YOM | 2020 | Mileage | 41,697 |
| Registration No. | NDL4248 | Chassis No. | MRHDG1840LP000018 |

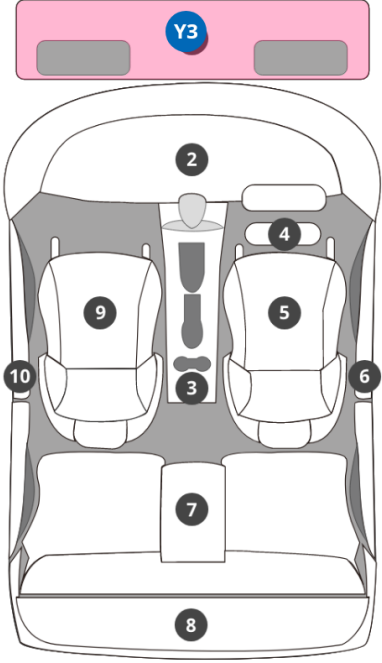
| <b>Interior Evaluation :</b> <b>B</b> | <b>Exterior Evaluation :</b> <b>B</b> |
| <b>Remarks</b><br>Ceiling - Grime - Medium | <b>Remarks</b><br>(L) Rear Door, Molding - Scratch & Dent - Minimal / (R) Mirror - Scratch - Small / (R) Rear Door, Molding - Scratch - Small / (R) Rear Fender, Molding - Scratch & Dent - Medium / Front Bumper, Grille, Lamps - Scratch - Medium / Rear Bumper, Lamps, Panels - Scratch & Dent - Small / Trunk Hood, Rear Gate - Scratch & Dent - Small / (L) Front Door, Molding - Scratch - Minimal |
