General Information

Make	Suzuki	Model	Vitara
YOM	2019	Mileage	89,132
Registration No.	MAI1793	Chassis No.	TSMYD21S0KM485160
CC	1.6	Transmission	A/T
Fuel Type	Gas	Type of Body	SUV
Colour	Orange

Body / Panel Condition

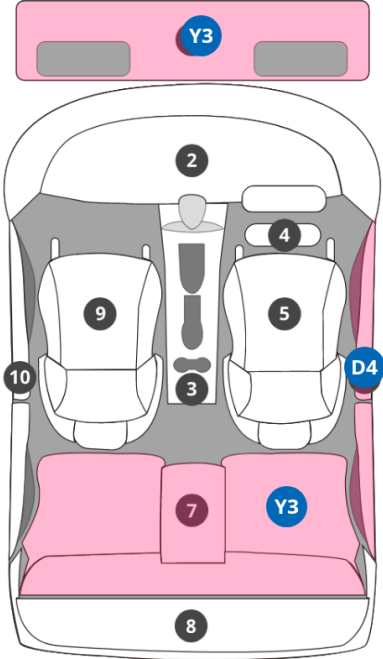
Interior Evaluation : C	Exterior Evaluation : E

<p>a : Cut, Fray d : Loose, Deformed k : Animal Hair s : Smell t : Cigarette Burns x : Defective y : Stain</p>

<p>A : Scratch AU : Scratch & Dent B : Modified C : Corrosion G : Stone chip P : Faded S : Rust SC : Rust & Corrosion U : Dent X : Defective Y : Crack, Gap</p>
<p>Remarks Ceiling - Grime - Medium / (R) Front Trim - Worked - Large / Rear Seat - Grime - Medium</p>	<p>Remarks Bonnet - Repair Traces - Yes / (L) Rear Fender - Repair Traces - Yes / (R) Rear Fender - Repair Traces - Yes / (L) Front Door, Molding - Scratch & Dent - Large / (L) Rear Door, Molding - Scratch & Dent - Large / (L) Mirror - Scratch - Small / (L) Rear Fender, Molding - Scratch & Dent - Small / (R) Rear Door, Molding - Dent - Large / (R) Front Fender, Molding - Scratch & Dent - Medium / (R) Mirror - Scratch - Medium / Rear Bumper, Lamps, Panels - Repair mark - Yes / Rear Bumper, Lamps, Panels - Scratch & Dent - Small / Roof - Dent - Small / Front Bumper, Grille, Lamps - Scratch - Medium / Bonnet, Headlight - Dent - Small / (R) Front Door, Molding - Scratch - Small / (R) Rear Fender, Molding - Scratch - Medium</p>
