General Information

Make	Toyota	Model	Hilux
YOM	2021	Odo Meter Reading	107,791
Registration No.	NGA6998	Chassis No.	MR0BA8CD6L0235141
CC	2.8	Transmission	M/T
Fuel Type	Diesel	Type of Body	Pickup
Colour	White

Body / Panel Condition

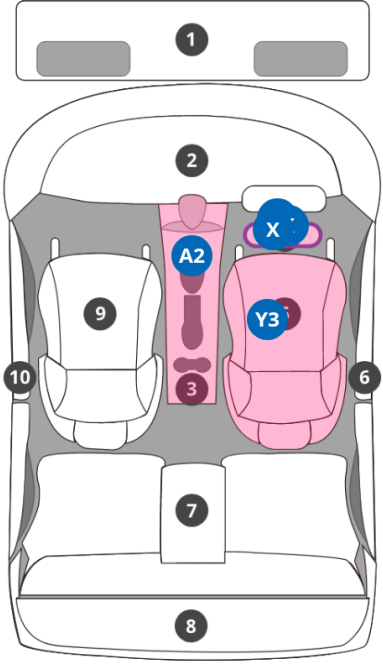
Interior Evaluation : C	Exterior Evaluation : B

<p>a : Cut, Fray d : Loose, Deformed k : Animal Hair s : Smell t : Cigarette Burns x : Defective y : Stain</p>

<p>A : Scratch AU : Scratch & Dent B : Modified C : Corrosion G : Stone chip P : Faded S : Rust SC : Rust & Corrosion U : Dent X : Defective Y : Crack, Gap</p>
<p>Remarks Mat Other - Missing - Yes / (R) Front Floor Mat - Missing - Yes / (L) Front Floor Mat - Missing - Yes / (R) Front Seat - Grime - Medium / Knobs - Worn, Peel, Crack - Small / Overall Interior - Worn as per age - Yes</p>	<p>Remarks (R) Rear Door - Repair Traces - Yes / (R) Side Gate - Repair mark - Yes / (R) Front Door, Molding - Repair mark - Yes / (R) Mirror - Scratch - Minimal / (R) Front Fender, Molding - Dent - Minimal / (R) Side Gate - Dent - Small / Cargo Bed Floor - Crack, Gap - Small / Rear Gate - Dent - Small / Rear Bumper, Lamps, Panels - Scratch - Small / Front Bumper, Grille, Lamps - Scratch - Small</p>
