General Information

Make	Toyota	Model	Vios
YOM	2020	Odo Meter Reading	77,368
Registration No.	DBA5757	Chassis No.	PA1B18F30L4116919
CC	1.3	Transmission	CVT
Fuel Type	Gas	Type of Body	Sedan
Colour	Red Mica Metallic

Body / Panel Condition

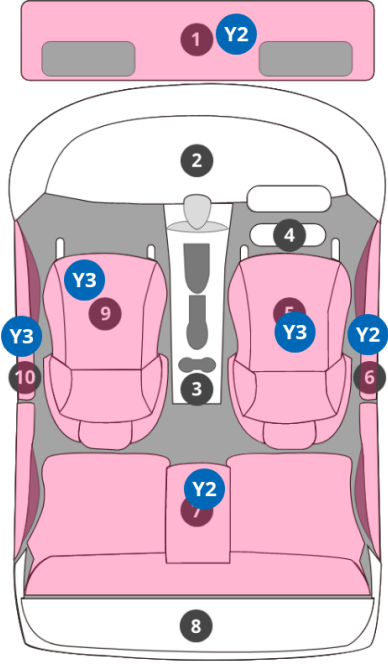
Interior Evaluation : B	Exterior Evaluation : D

<p>a : Cut, Fray d : Loose, Deformed k : Animal Hair s : Smell t : Cigarette Burns x : Defective y : Stain</p>

<p>A : Scratch AU : Scratch & Dent B : Modified C : Corrosion G : Stone chip P : Faded S : Rust SC : Rust & Corrosion U : Dent X : Defective Y : Crack, Gap</p>
<p>Remarks (R) Front Seat - Grime - Medium / (L) Front Seat - Grime - Medium / Rear Seat - Grime - Small / (R) Front Trim - Grime - Small / (L) Front Trim - Grime - Medium / Ceiling - Grime - Small</p>	<p>Remarks (L) Rear Door - Repair Traces - Yes / (R) Front Fender, Molding - Dent - Medium / (R) Front Door, Molding - Scratch - Medium / (R) Rear Door, Molding - Scratch - Small / (R) Rear Fender, Molding - Scratch - Small / Rear Bumper, Lamps, Panels - Scratch & Dent - Medium / (L) Rear Door, Molding - Scratch & Dent - Small / (L) Front Door, Molding - Scratch & Dent - Small / (L) Front Fender, Molding - Scratch & Dent - Medium / Front Bumper, Grille, Lamps - Scratch & Dent - Large / Member (Bolted) - Dent - Yes / Bonnet, Headlight - Scratch - Small / Roof - Scratch & Dent - Small</p>

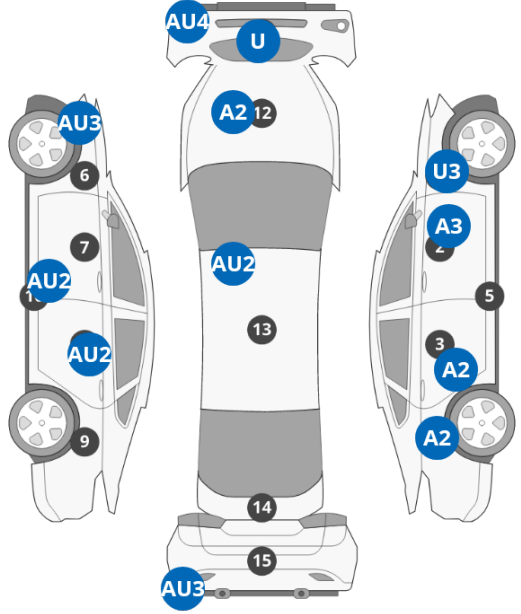
<p>Inspector Notes</p>
<p>with warranty booklet, with jack, incomplete tools, with spare tire, with LTO plate, scratch and crack tail light,</p>
