General Information

Make	Toyota	Model	Wigo
YOM	2024	Odo Meter Reading	39,203
Registration No.	BAG2948	Chassis No.	MHKAA1BC7RJ017129
CC	1.0	Transmission	CVT
Fuel Type	Gas	Type of Body	Hatchback
Colour	Yellow

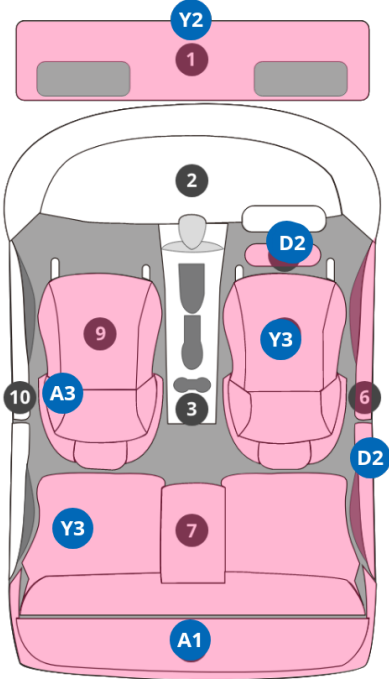
Interior Evaluation : C	Exterior Evaluation : C

<p>a : Cut, Fray d : Loose, Deformed k : Animal Hair s : Smell t : Cigarette Burns x : Defective y : Stain</p>

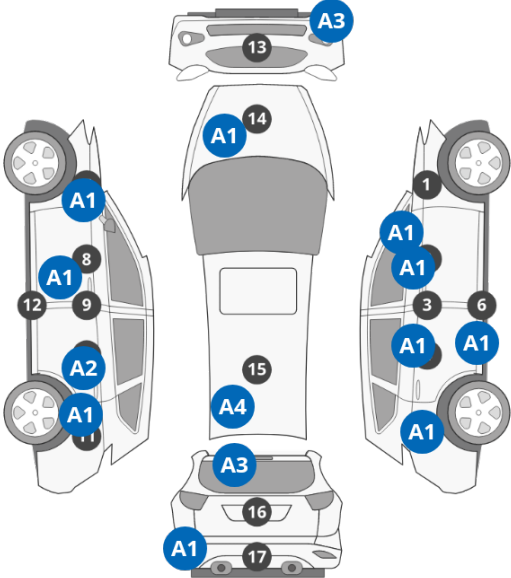
<p>A : Scratch AU : Scratch & Dent B : Modified C : Corrosion G : Stone chip P : Faded S : Rust SC : Rust & Corrosion U : Dent X : Defective Y : Crack, Gap</p>
<p>Remarks Trunk Room - Worn, Scratch, Cut, Crack - Minimal / Rear Seat - Grime - Medium / (R) Rear Trim - Worked - Small / (R) Front Seat - Grime - Medium / (R) Front Floor Mat - Grime - Small / (L) Front Floor Mat - Worked - Small / Ceiling - Grime - Small / (L) Front Seat - Cut, Crack - Medium</p>	<p>Remarks (R) Mirror - Scratch - Minimal / (R) Front Door, Molding - Scratch - Minimal / (R) Step, In-panel, Side Spoiler - Scratch - Minimal / (R) Rear Door, Molding - Scratch - Minimal / (R) Rear Fender, Molding - Scratch - Minimal / Rear Bumper, Lamps, Panels - Scratch - Minimal / Trunk Hood, Rear Gate - Scratch - Medium / Roof - Scratch - Large / (L) Rear Door, Molding - Scratch - Small / (L) Rear Fender, Molding - Scratch - Minimal / (L) Front Door, Molding - Scratch - Minimal / (L) Front Fender, Molding - Scratch - Minimal / Front Bumper, Grille, Lamps - Scratch - Medium / Bonnet, Headlight - Scratch - Minimal</p>
