General Information

Make	Toyota	Model	Vios
YOM	2021	Odo Meter Reading	29,733
Registration No.	NEL3203	Chassis No.	PA1B18F37M4148395
CC	1.3	Transmission	CVT
Fuel Type	Gas	Type of Body	Sedan
Colour	Blue

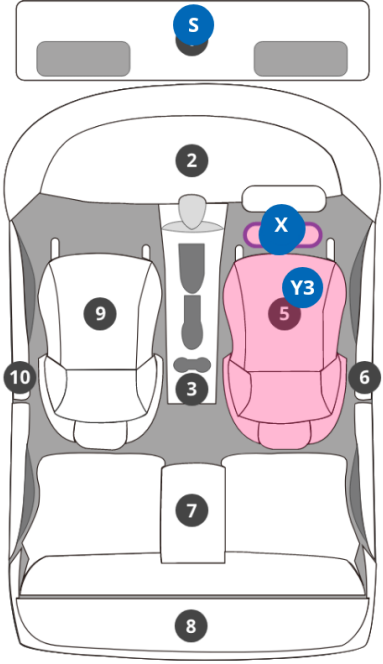
<p>a : Cut, Fray d : Loose, Deformed k : Animal Hair s : Smell t : Cigarette Burns x : Defective y : Stain</p>

<p>A : Scratch AU : Scratch & Dent B : Modified C : Corrosion G : Stone chip P : Faded S : Rust SC : Rust & Corrosion U : Dent X : Defective Y : Crack, Gap</p>
<p>Remarks (L) Front Floor Mat - Missing - Yes / (R) Front Floor Mat - Missing - Yes / Mat Other - Missing - Yes / Overall Interior - Smell - Yes / (R) Front Seat - Grime - Medium</p>	<p>Remarks (R) Front Door - Repair Traces - Yes / (R) Front Fender - Repair Traces - Yes / Bonnet - Repair Traces - Yes / Bonnet, Headlight - Repair mark - Yes / (R) Front Fender, Molding - Scratch - Minimal / (R) Front Door, Molding - Scratch - Minimal / (R) Rear Door, Molding - Scratch & Dent - Small / (R) Rear Fender, Molding - Scratch - Minimal / Rear Bumper, Lamps, Panels - Scratch & Dent - Small / Trunk Hood, Rear Gate - Scratch - Minimal / (L) Rear Fender, Molding - Scratch - Minimal / (L) Rear Door, Molding - Scratch & Dent - Minimal / (L) Front Door, Molding - Scratch - Minimal / (L) Front Fender, Molding - Scratch - Minimal / Bonnet, Headlight - Scratch - Minimal / Roof - Scratch - Minimal</p>
