General Information

Make	Toyota	Model	Vios
YOM	2024	Odo Meter Reading	29,272
Registration No.	NFR5289	Chassis No.	PA1B18F38R4252109
CC	1.3	Transmission	CVT
Fuel Type	Gas	Type of Body	Sedan
Colour	Blue

Body / Panel Condition

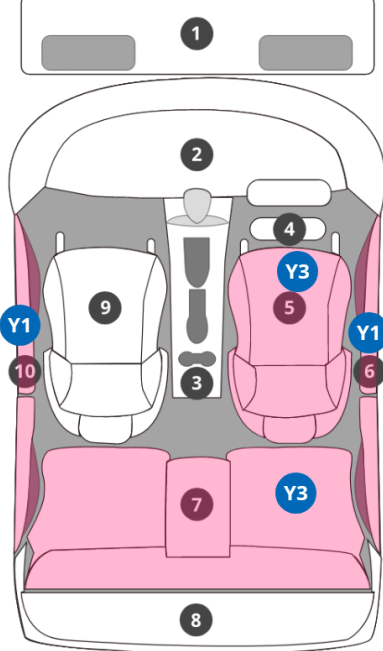
Interior Evaluation : B	Exterior Evaluation : C

<p>a : Cut, Fray d : Loose, Deformed k : Animal Hair s : Smell t : Cigarette Burns x : Defective y : Stain</p>

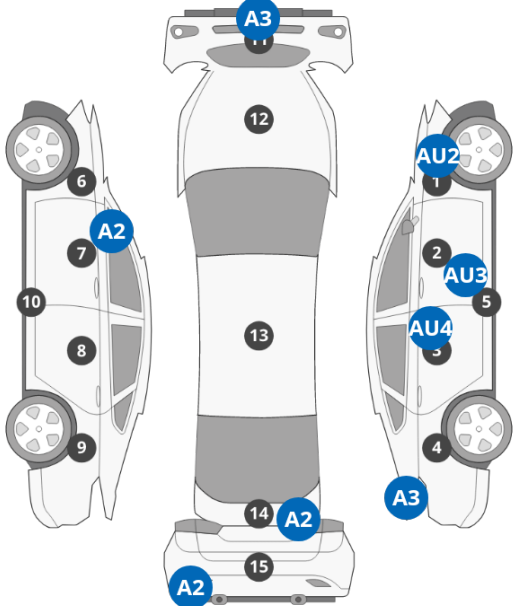
<p>A : Scratch AU : Scratch & Dent B : Modified C : Corrosion G : Stone chip P : Faded S : Rust SC : Rust & Corrosion U : Dent X : Defective Y : Crack, Gap</p>
<p>Remarks (R) Front Seat - Grime - Medium / Rear Seat - Grime - Medium / (R) Front Trim - Grime - Minimal / (L) Front Trim - Grime - Minimal</p>	<p>Remarks (R) Front Fender, Molding - Scratch & Dent - Small / (R) Front Door, Molding - Scratch & Dent - Medium / (R) Rear Door, Molding - Scratch & Dent - Large / Rear Bumper, Lamps, Panels - Scratch - Small / Trunk Hood, Rear Gate - Scratch - Small / (R) Rear Fender, Molding - Scratch - Medium / (L) Mirror - Scratch - Small / Front Bumper, Grille, Lamps - Scratch - Medium</p>
Frame Evaluation : A	Functional Evaluation : C
<p>Remarks Defects not found</p>	<p>Remarks Power Steering - Issue - Yes / Battery - Weak - Yes / Reverse Camera - N/A - Yes / Spare Key - Issue - Unexist</p>

<p>Inspector Notes</p>
<p>no warranty booklet, with jack and tools, with spare tire, with LTO plate, weak battery, power steering issue due to weak battery</p>
