## General Information

| Make | Toyota | Model | Vios |
| YOM | 2024 | Odo Meter Reading | 33,108 |

## Body / Panel Condition

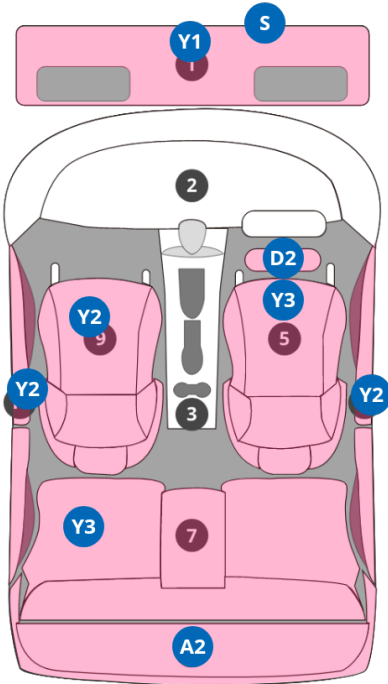
| Interior Evaluation : <span style="color: red;">C</span> | Exterior Evaluation : <span style="color: red;">C</span> |
| <b>Remarks</b><br>Trunk Room - Worn, Scratch, Cut, Crack - Small / Rear Seat - Grime - Medium / (R) Front Seat - Grime - Medium / (L) Front Trim - Grime - Small / Overall Interior - Smell - Yes / (L) Front Floor Mat - Worked - Small / (R) Front Trim - Grime - Small / (L) Front Seat - Grime - Small / Ceiling - Grime - Minimal | <b>Remarks</b><br>(R) Front Fender, Molding - Scratch - Large / (R) Front Door, Molding - Scratch - Small / (R) Rear Door, Molding - Scratch - Minimal / (R) Rear Fender, Molding - Scratch - Minimal / Rear Bumper, Lamps, Panels - Scratch - Minimal / Trunk Hood, Rear Gate - Scratch - Small / (L) Rear Fender, Molding - Scratch - Small / (L) Rear Door, Molding - Scratch & Dent - Minimal / Roof - Scratch - Small / (L) Front Door, Molding - Scratch - Small / (L) Front Fender, Molding - Scratch - Minimal / Front Bumper, Grille, Lamps - Scratch - Medium / Bonnet, Headlight - Scratch - Small |
