General Information

Make	Toyota	Model	Vios
YOM	2024	Odo Meter Reading	9,179
Registration No.	NKC8595	Chassis No.	PA1B18F33R4257038
CC	1.3	Transmission	CVT
Fuel Type	Gas	Type of Body	Sedan
Colour	Red Mica Metallic

Body / Panel Condition

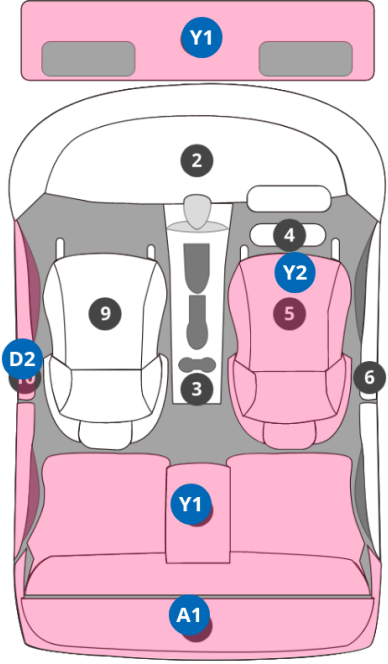
Interior Evaluation : A	Exterior Evaluation : C

<p>a : Cut, Fray d : Loose, Deformed k : Animal Hair s : Smell t : Cigarette Burns x : Defective y : Stain</p>

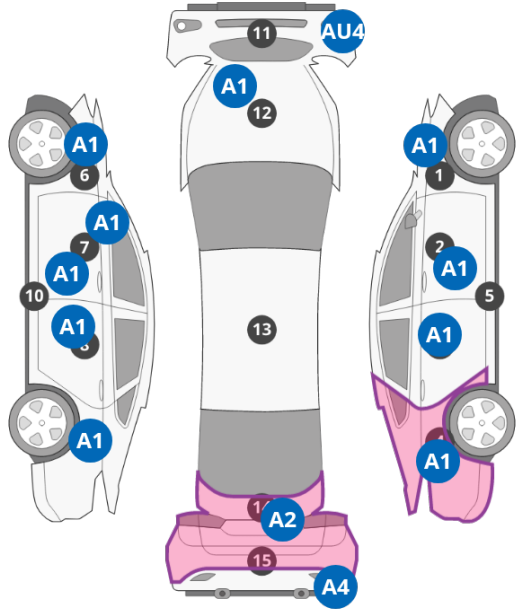
<p>A : Scratch AU : Scratch & Dent B : Modified C : Corrosion G : Stone chip P : Faded S : Rust SC : Rust & Corrosion U : Dent X : Defective Y : Crack, Gap</p>
<p>Remarks (R) Front Seat - Grime - Small / Trunk Room - Worn, Scratch, Cut, Crack - Minimal / Rear Seat - Grime - Minimal / (L) Front Trim - Worked - Small / Ceiling - Grime - Minimal</p>	<p>Remarks Trunk Hood, Rear Gate - Repair Traces - Yes / (R) Rear Fender - Repair Traces - Yes / (R) Rear Fender, Molding - Repair mark - Yes / Trunk Hood, Rear Gate - Repair mark - Yes / (R) Front Fender, Molding - Scratch - Minimal / (R) Front Door, Molding - Scratch - Minimal / (R) Rear Door, Molding - Scratch - Minimal / (R) Rear Fender, Molding - Scratch - Minimal / Rear Bumper, Lamps, Panels - Scratch - Large / Trunk Hood, Rear Gate - Scratch - Small / (L) Rear Fender, Molding - Scratch - Minimal / (L) Rear Door, Molding - Scratch - Minimal / (L) Front Door, Molding - Scratch - Minimal / (L) Mirror - Scratch - Minimal / (L) Front Fender, Molding - Scratch - Minimal / Front Bumper, Grille, Lamps - Scratch & Dent - Large / Bonnet, Headlight - Scratch - Minimal</p>
