## General Information

| Make | Toyota | Model | Vios |
| YOM | 2022 | Mileage | 45,598 |
| Registration No. | NHB7031 | Chassis No. | PA1B18F39N4179326 |

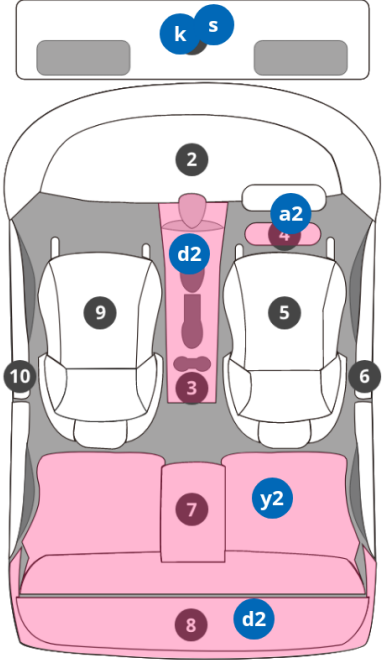
| <b>Interior Evaluation :</b> <b>B</b> | <b>Exterior Evaluation :</b> <b>B</b> |
| <b>Remarks</b><br>Console, Switchs, Vents - Loose, Deformed, Grime - Small / (L) Front Floor Lag - Cut, Crack - Small / Trunk Room - Loose, Deformed, Grime - Small / Rear Seat - Grime - Small / Overall Interior - Animal Hair - Yes / Overall Interior - Smell - Yes | <b>Remarks</b><br>Roof - Repair Traces - Yes / (L) Front Fender, Molding - Scratch & Dent - Minimal / Front Bumper, Grille, Lamps - Scratch & Dent - Small / (L) Front Door, Molding - Scratch - Small / (L) Rear Door, Molding - Scratch & Dent - Small / (L) Rear Fender, Molding - Scratch - Small / Trunk Hood, Rear Gate - Scratch - Minimal / (R) Rear Door, Molding - Scratch - Medium / (R) Step, In-panel, Side Spoiler - Scratch - Minimal / (R) Front Door, Molding - Scratch - Small / (R) Front Fender, Molding - Scratch & Dent - Minimal / Bonnet, Headlight - Dent - Minimal |

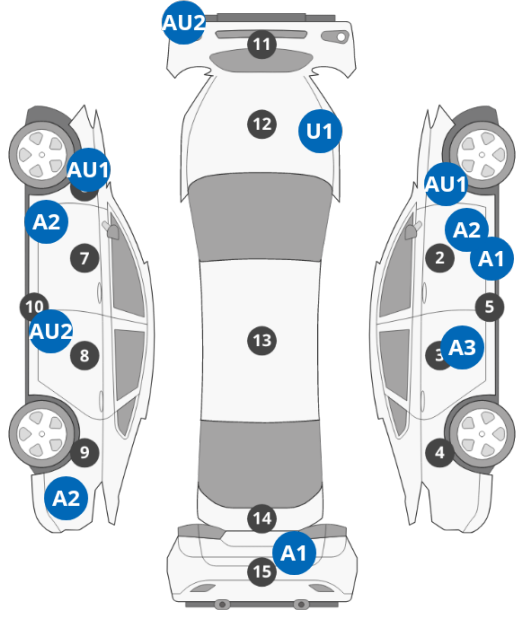
| Inspector Notes |
|---|
| roof was repainted to black. more minimal scratches at trunk door. more light scratches around the exterior. rightside reverselight issue. flip key issue. |
