## General Information

| Make | Toyota | Model | Hiace |
| Registration No. | DA408B | Chassis No. | JTFNAFAP0S8055352 |

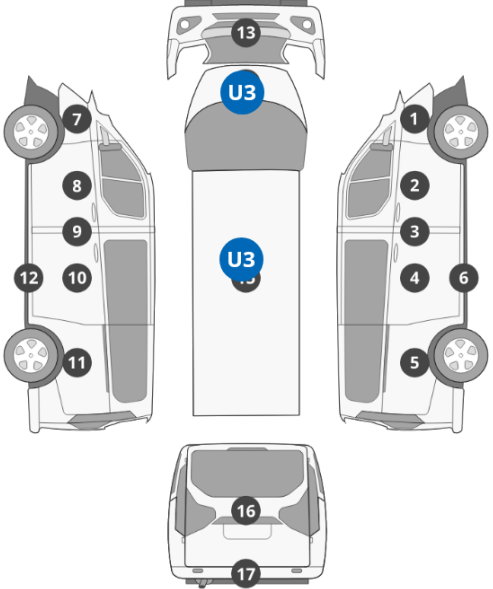
| Interior Evaluation : <b>A</b> | Exterior Evaluation : <b>B</b> |
| <b>Remarks</b><br>Defects not found | <b>Remarks</b><br>Bonnet, Headlight - Dent - Medium / Roof - Dent - Medium |

cluster of dents on roof and hood.
