## General Information

| Make | Toyota | Model | Hiace |
| Registration No. | DA484B | Chassis No. | JTFWA3APXS8020286 |

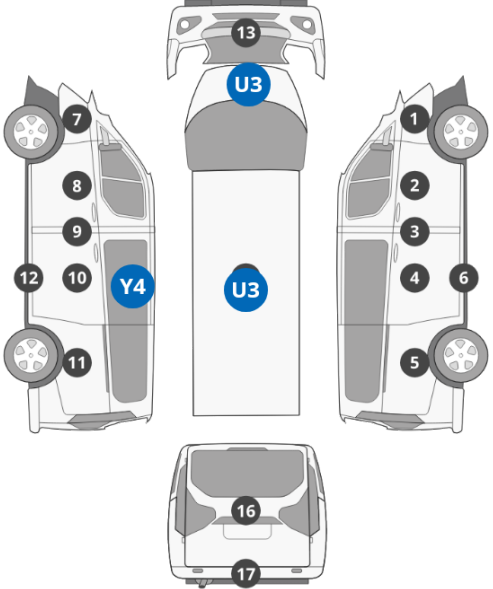
| Interior Evaluation : <b>A</b> | Exterior Evaluation : <b>C</b> |
| <b>Remarks</b><br>Defects not found | <b>Remarks</b><br>Roof - Dent - Medium / Bonnet, Headlight - Dent - Medium / (L) Side Window - Damaged - Large |

Damaged left side window. Cluster of dents at Hood and roof
