## General Information

| Make | Toyota | Model | Avanza |

## Body / Panel Condition

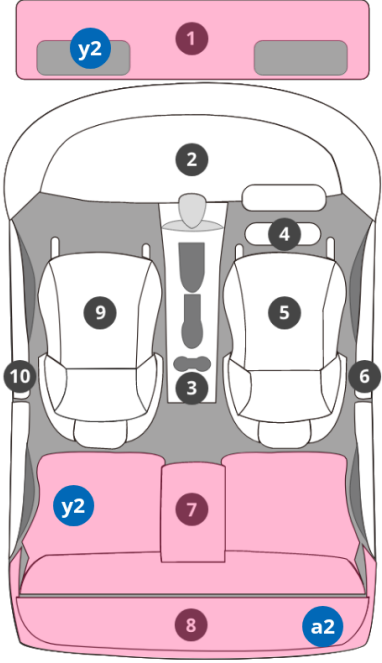
| <b>Interior Evaluation :</b> <span style="color: red; font-weight: bold;">A</span> | <b>Exterior Evaluation :</b> <span style="color: red; font-weight: bold;">C</span> |
| <b>Remarks</b><br>Sunvisor, Sunglass Holder - Grime - Small / Rear Seat - Grime - Small / Trunk Room - Worn, Scratch, Cut, Crack - Small | <b>Remarks</b><br>Trunk Hood, Rear Gate - Repair Traces - Yes / (L) Front Fender, Molding - Dent - Minimal / (L) Front Door, Molding - Dent - Small / (L) Rear Door, Molding - Scratch & Dent - Minimal / (L) Rear Fender, Molding - Dent - Small / Rear Bumper, Lamps, Panels - Scratch - Minimal / (R) Rear Fender, Molding - Dent - Small / (R) Rear Door, Molding - Dent - Small / (R) Front Door, Molding - Scratch - Minimal / (R) Mirror - Scratch - Minimal / Front Bumper, Grille, Lamps - Scratch - Small / Bonnet, Headlight - Scratch & Dent - Minimal / Roof - Dent - Large |

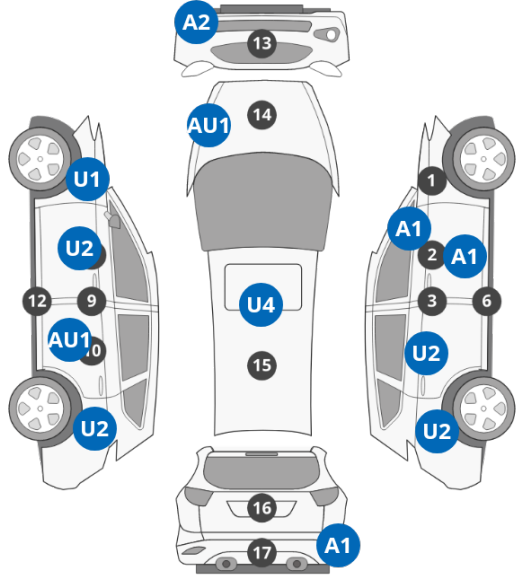
| more dent at the left reardoor. More scratches at the rear trunk. bumperguard loose. more light scratches around the exterior. 2nd row seats has molds. |
