## General Information

| Make | Toyota | Model | Rush |
| Registration No. | NEB5172 | Chassis No. | MHKE8FE2PKK001610 |

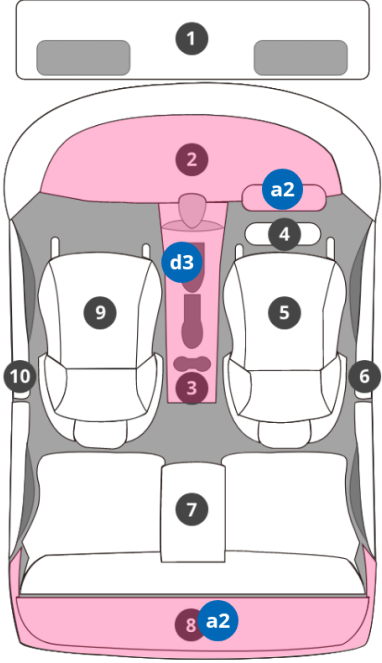
| <b>Interior Evaluation :</b> <b>B</b> | <b>Exterior Evaluation :</b> <b>C</b> |
| <b>Remarks</b><br>Steering Wheel - Worn, Peel, Crack - Small / Trunk Room - Worn, Scratch, Cut, Crack - Small / Console, Switchs, Vents - Loose, Deformed, Grime - Medium | <b>Remarks</b><br>Roof - Repair Traces - Yes / Front Bumper, Grille, Lamps - Scratch & Dent - Large / (R) Mirror - Crack - Cracks / Rear Bumper, Lamps, Panels - Crack, Gap - Medium / Trunk Hood, Rear Gate - Dent - Large |

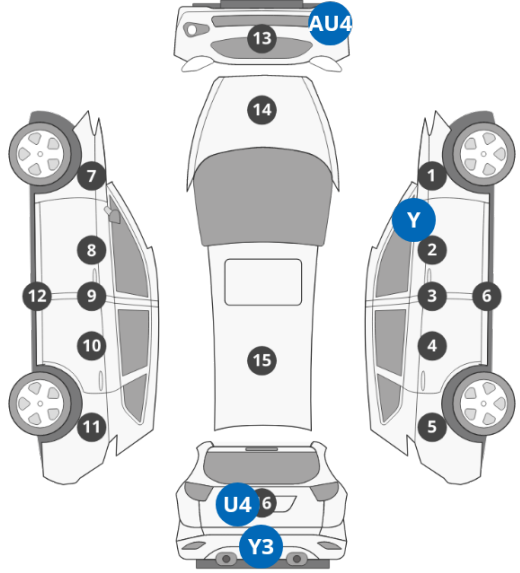
| Inspector Notes |
|---|
| reverse camera not function/roof covered carbon sticker/has aftermarket mudflaps/ aftermarket wheels and fender extension/ aftermarket front grill |
