General Information

Make	Toyota	Model	Vios
YOM	2024	Odo Meter Reading	8,576
Registration No.	NEY5298	Chassis No.	PA1B18F36R4256496
CC	1.3	Transmission	CVT
Fuel Type	Gas	Type of Body	Sedan
Colour	Blue

Body / Panel Condition

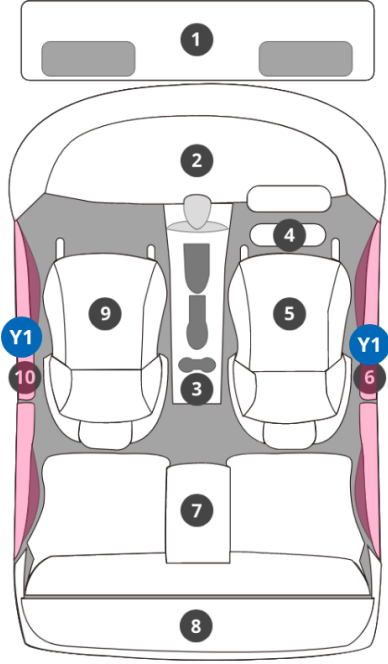
Interior Evaluation : A	Exterior Evaluation : C

<p>a : Cut, Fray d : Loose, Deformed k : Animal Hair s : Smell t : Cigarette Burns x : Defective y : Stain</p>

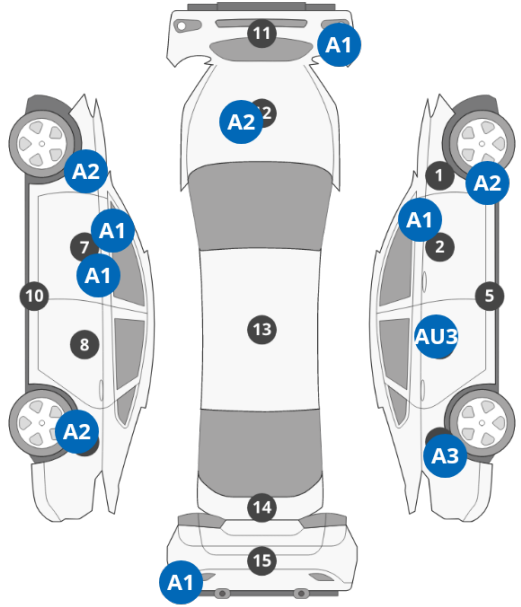
<p>A : Scratch AU : Scratch & Dent B : Modified C : Corrosion G : Stone chip P : Faded S : Rust SC : Rust & Corrosion U : Dent X : Defective Y : Crack, Gap</p>
<p>Remarks (R) Front Trim - Grime - Minimal / (L) Front Trim - Grime - Minimal</p>	<p>Remarks (R) Mirror - Scratch - Minimal / (R) Front Fender, Molding - Scratch - Small / (R) Rear Door, Molding - Scratch & Dent - Medium / (R) Rear Fender, Molding - Scratch - Medium / Rear Bumper, Lamps, Panels - Scratch - Minimal / (L) Rear Fender, Molding - Scratch - Small / (L) Front Door, Molding - Scratch - Minimal / (L) Mirror - Scratch - Minimal / (L) Front Fender, Molding - Scratch - Small / Front Bumper, Grille, Lamps - Scratch - Minimal / Bonnet, Headlight - Scratch - Small</p>
