## General Information

| Make | Toyota | Model | Vios |
| Registration No. | NKA7966 | Chassis No. | PA1B18F38P4236652 |

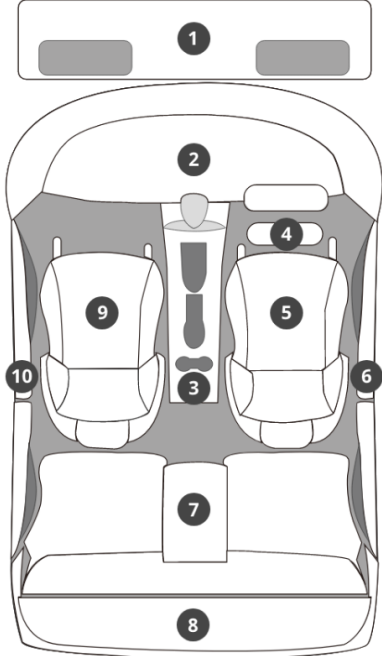
| Interior Evaluation : <span style="color: red; font-weight: bold;">A</span> | | Exterior Evaluation : <span style="color: red; font-weight: bold;">C</span> | |
| <p><b>Remarks</b><br/>Defects not found</p> | | <p><b>Remarks</b><br/>(L) Front Fender, Molding - Dent - Medium / Member (Bolted) - Dent - Yes / Front Bumper, Grille, Lamps - Scratch - Medium / (R) Rear Door, Molding - Scratch &amp; Dent - Medium / (R) Rear Fender, Molding - Scratch &amp; Dent - Medium / Trunk Hood, Rear Gate - Scratch - Small / Roof - Dent - Minimal / (L) Rear Door, Molding - Scratch - Minimal / (L) Front Door, Molding - Scratch - Small</p> | |
