General Information

Make	Toyota	Model	Raize
YOM	2024	Mileage	18,199
Registration No.	NKE3670	Chassis No.	MHKAB1BA8RJ090344
CC	1.2	Transmission	CVT
Fuel Type	Gas	Type of Body	SUV
Colour	Silver

Body / Panel Condition

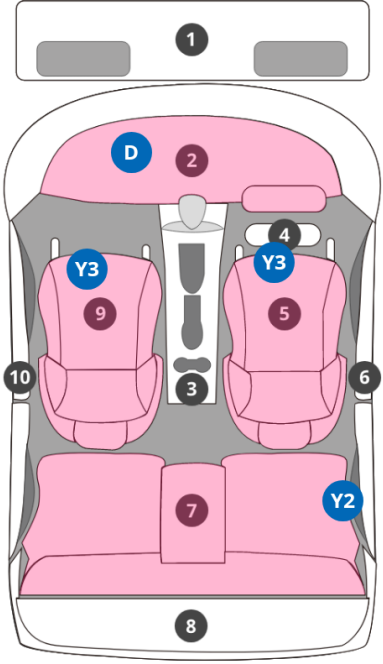
Interior Evaluation : B	Exterior Evaluation : D

<p>a : Cut, Fray d : Loose, Deformed k : Animal Hair s : Smell t : Cigarette Burns x : Defective y : Stain</p>

<p>A : Scratch AU : Scratch & Dent B : Modified C : Corrosion G : Stone chip P : Faded S : Rust SC : Rust & Corrosion U : Dent X : Defective Y : Crack, Gap</p>
Remarks (R) Front Seat - Grime - Medium / (L) Front Seat - Grime - Medium / Rear Seat - Grime - Small / Dashboard - Traces of Adhesive Tape - Yes	Remarks (L) Front Fender, Molding - Partially Missing - Yes / (R) Front Fender, Molding - Scratch - Small / (R) Front Door, Molding - Scratch - Minimal / (R) Rear Door, Molding - Scratch & Dent - Medium / (R) Rear Fender, Molding - Scratch - Small / Rear Bumper, Lamps, Panels - Scratch - Small / Trunk Hood, Rear Gate - Scratch - Minimal / (L) Rear Fender, Molding - Scratch - Minimal / (L) Rear Door, Molding - Scratch - Medium / (L) Mirror - Scratch - Medium / (L) Front Door, Molding - Scratch - Minimal / (L) Front Fender, Molding - Scratch & Dent - Small / Front Bumper, Grille, Lamps - Crack, Gap - Medium

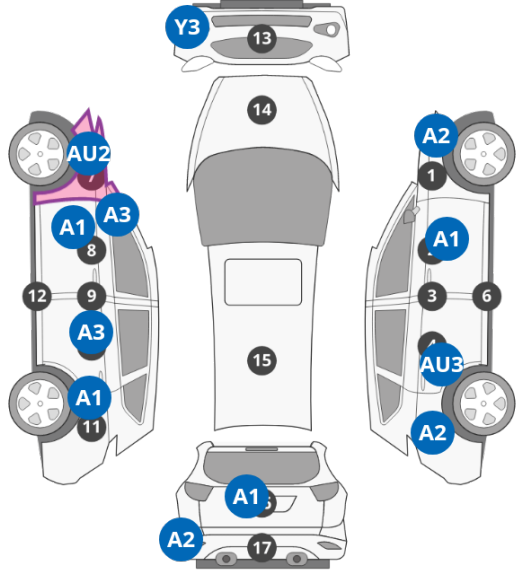
Inspector Notes
with warranty booklet, with jack and tools, with spare tire, with LTO plate, left front fender partially missing
