General Information

Make	Toyota	Model	Vios
YOM	2024	Odo Meter Reading	25,085
Registration No.	NKC8461	Chassis No.	PA1B18F39R4254547
CC	1.3	Transmission	CVT
Fuel Type	Gas	Type of Body	Sedan
Colour	Red Mica Metallic

Body / Panel Condition

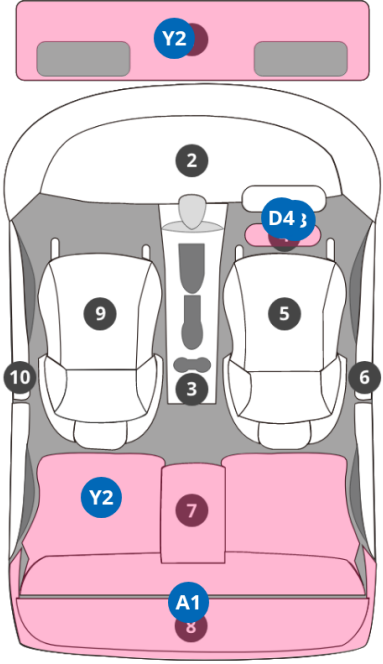
Interior Evaluation : C	Exterior Evaluation : E

<p>a : Cut, Fray d : Loose, Deformed k : Animal Hair s : Smell t : Cigarette Burns x : Defective y : Stain</p>

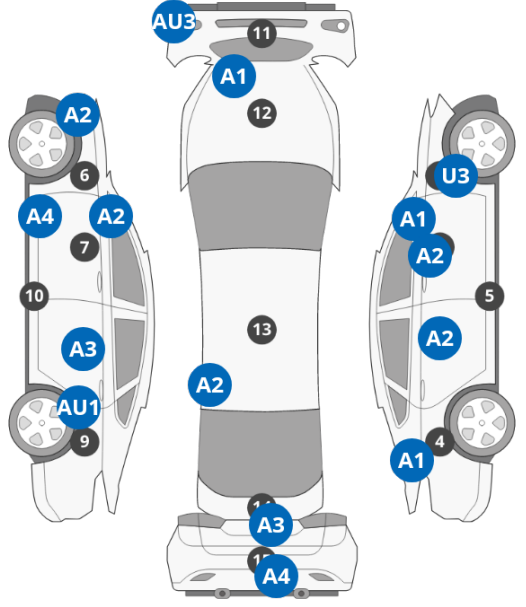
<p>A : Scratch AU : Scratch & Dent B : Modified C : Corrosion G : Stone chip P : Faded S : Rust SC : Rust & Corrosion U : Dent X : Defective Y : Crack, Gap</p>
<p>Remarks Trunk Room - Worn, Scratch, Cut, Crack - Minimal / Rear Seat - Grime - Small / (R) Front Floor Mat - Grime - Medium / (L) Front Floor Mat - Worked - Large / Ceiling - Grime - Small</p>	<p>Remarks (R) Front Fender, Molding - Dent - Medium / (R) Mirror - Scratch - Minimal / (R) Front Door, Molding - Scratch - Small / (R) Rear Door, Molding - Scratch - Small / (R) Rear Fender, Molding - Scratch - Minimal / Rear Bumper, Lamps, Panels - Scratch - Large / Trunk Hood, Rear Gate - Scratch - Medium / Roof - Scratch - Small / (L) Rear Fender, Molding - Scratch & Dent - Minimal / (L) Rear Door, Molding - Scratch - Medium / (L) Front Door, Molding - Scratch - Large / (L) Mirror - Scratch - Small / (L) Front Fender, Molding - Scratch - Small / Front Bumper, Grille, Lamps - Scratch & Dent - Medium / Bonnet, Headlight - Scratch - Minimal</p>
