General Information

Make	Toyota	Model	Vios
YOM	2024	Odo Meter Reading	5,998
Registration No.	NFR1217	Chassis No.	PA1B18F3XR4247445
CC	1.3	Transmission	CVT
Fuel Type	Gas	Type of Body	Sedan
Colour	Blue

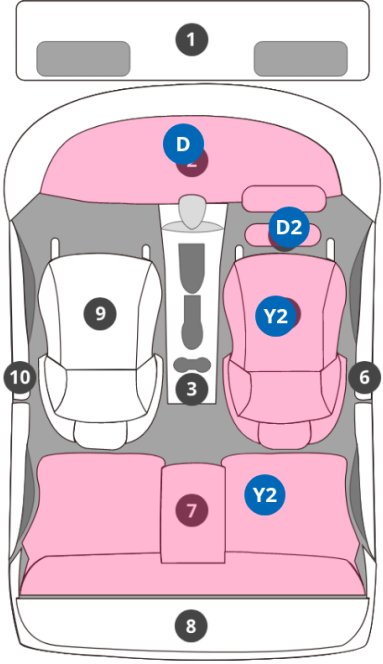
Interior Evaluation : A	Exterior Evaluation : D

<p>a : Cut, Fray d : Loose, Deformed k : Animal Hair s : Smell t : Cigarette Burns x : Defective y : Stain</p>

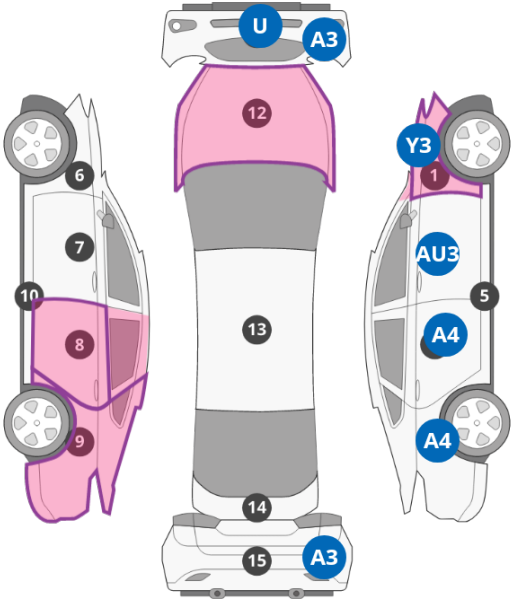
<p>A : Scratch AU : Scratch & Dent B : Modified C : Corrosion G : Stone chip P : Faded S : Rust SC : Rust & Corrosion U : Dent X : Defective Y : Crack, Gap</p>
<p>Remarks (R) Front Seat - Grime - Small / Rear Seat - Grime - Small / Dashboard - Traces of Adhesive Tape - Yes / (L) Front Floor Mat - Worked - Small</p>	<p>Remarks (R) Front Fender - Repair Traces - Yes / Bonnet - Repair Traces - Yes / (L) Rear Door - Repair Traces - Yes / (L) Rear Fender - Repair Traces - Yes / Member (Bolted) - Dent - Yes / Bonnet, Headlight - Repair mark - Yes / (R) Front Fender, Molding - Repair mark - Yes / (L) Rear Fender, Molding - Repair mark - Yes / (L) Rear Door, Molding - Repair mark - Yes / (R) Front Fender, Molding - Crack, Gap - Medium / (R) Front Door, Molding - Scratch & Dent - Medium / (R) Rear Door, Molding - Scratch - Large / (R) Rear Fender, Molding - Scratch - Large / Trunk Hood, Rear Gate - Scratch - Medium / Front Bumper, Grille, Lamps - Scratch - Medium</p>
