General Information

Make	Toyota	Model	Vios
YOM	2024	Odo Meter Reading	14,909
Registration No.	DBO2337	Chassis No.	PA1B18F36P4236942
CC	1.3	Transmission	CVT
Fuel Type	Gas	Type of Body	Sedan
Colour	Green

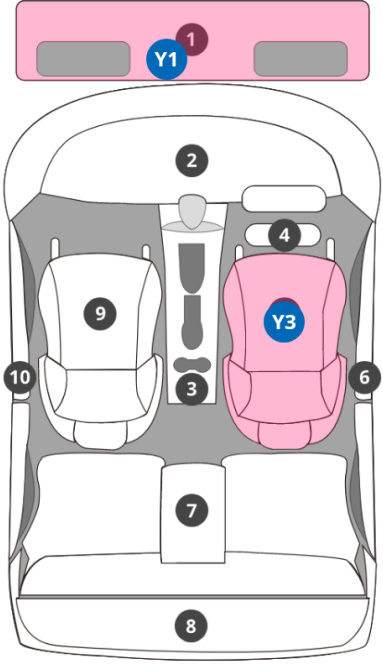
Interior Evaluation : B	Exterior Evaluation : C

<p>a : Cut, Fray d : Loose, Deformed k : Animal Hair s : Smell t : Cigarette Burns x : Defective y : Stain</p>

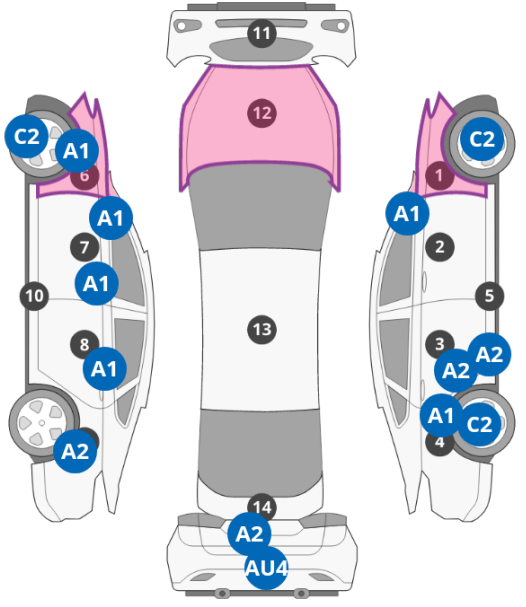
<p>A : Scratch AU : Scratch & Dent B : Modified C : Corrosion G : Stone chip P : Faded S : Rust SC : Rust & Corrosion U : Dent X : Defective Y : Crack, Gap</p>
Remarks (R) Front Seat - Grime - Medium / Ceiling - Grime - Minimal	Remarks (R) Front Fender - Repair Traces - Yes / Bonnet - Repair Traces - Yes / (L) Front Fender - Repair Traces - Yes / (R) Mirror - Scratch - Minimal / (R) Step, In-panel, Side Spoiler - Scratch - Small / (R) Rear Door, Molding - Scratch - Small / (R) Rear Fender, Molding - Scratch - Minimal / Rear Bumper, Lamps, Panels - Scratch & Dent - Large / Trunk Hood, Rear Gate - Scratch - Small / (L) Rear Fender, Molding - Scratch - Small / (L) Rear Door, Molding - Scratch - Minimal / (L) Front Door, Molding - Scratch - Minimal / (L) Mirror - Scratch - Minimal / (L) Front Fender, Molding - Scratch - Minimal / Bonnet, Headlight - Repair mark - Yes / (R) Front Fender, Molding - Repair mark - Yes / (L) Front Fender, Molding - Repair mark - Yes / (R) Front Wheel, Cover - Scratch, Corrosion - Small / (R) Rear Wheel, Cover - Scratch, Corrosion - Small / (L) Front Wheel, Cover - Scratch, Corrosion - Small
