General Information

Make	Toyota	Model	Vios
YOM	2024	Odo Meter Reading	19,787
Registration No.	EAG6908	Chassis No.	PA1B18F37P4232348
CC	1.3	Transmission	CVT
Fuel Type	Gas	Type of Body	Sedan
Colour	Red Mica Metallic

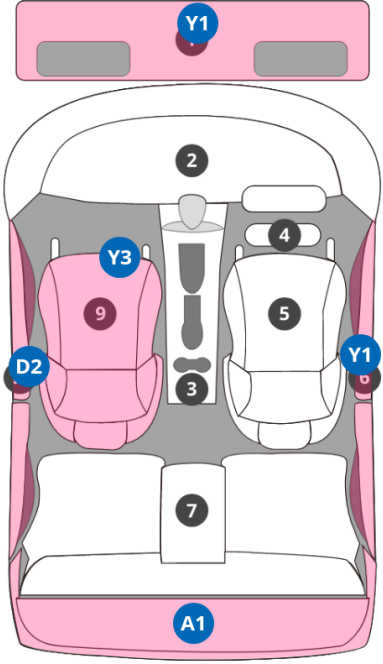
Interior Evaluation : B	Exterior Evaluation : B

<p>a : Cut, Fray d : Loose, Deformed k : Animal Hair s : Smell t : Cigarette Burns x : Defective y : Stain</p>

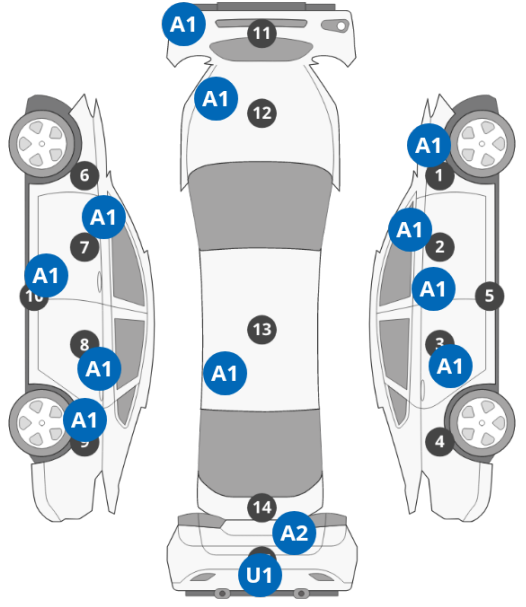
<p>A : Scratch AU : Scratch & Dent B : Modified C : Corrosion G : Stone chip P : Faded S : Rust SC : Rust & Corrosion U : Dent X : Defective Y : Crack, Gap</p>
<p>Remarks Trunk Room - Worn, Scratch, Cut, Crack - Minimal / (L) Front Trim - Worked - Small / (L) Front Seat - Grime - Medium / (R) Front Trim - Grime - Minimal / Ceiling - Grime - Minimal</p>	<p>Remarks (R) Front Fender, Molding - Scratch - Minimal / (R) Mirror - Scratch - Minimal / (R) Front Door, Molding - Scratch - Minimal / (R) Rear Door, Molding - Scratch - Minimal / Rear Bumper, Lamps, Panels - Dent - Minimal / Trunk Hood, Rear Gate - Scratch - Small / (L) Rear Fender, Molding - Scratch - Minimal / Roof - Scratch - Minimal / (L) Front Door, Molding - Scratch - Minimal / (L) Rear Door, Molding - Scratch - Minimal / (L) Mirror - Scratch - Minimal / Front Bumper, Grille, Lamps - Scratch - Minimal / Bonnet, Headlight - Scratch - Minimal</p>
