## General Information

| <b>Make</b> | Toyota | <b>Model</b> | Vios |

## Body / Panel Condition

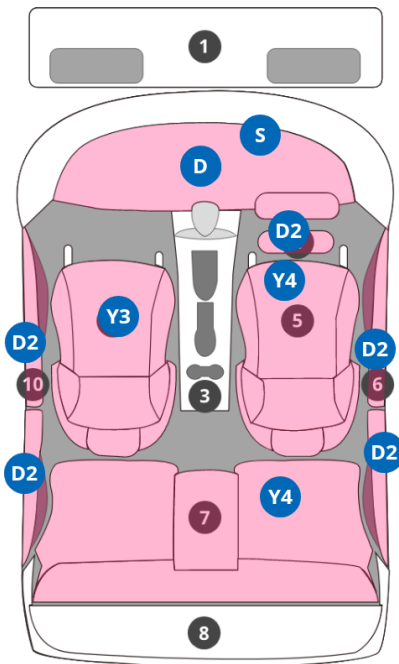
| <b>Interior Evaluation :</b> <span style="float: right; color: red; font-weight: bold;">C</span> | <b>Exterior Evaluation :</b> <span style="float: right; color: red; font-weight: bold;">D</span> |

| <p><b>Remarks</b><br/>(L) Front Seat - Grime - Medium / (L) Front Floor Mat - Worked - Small / (L) Front Trim - Worked - Small / Rear Seat - Grime - Large / (R) Front Seat - Grime - Large / Overall Interior - Worn as per age - Yes / Overall Interior - Smell - Yes / (R) Front Trim - Worked - Small / (R) Rear Trim - Worked - Small / (L) Rear Trim - Worked - Small / Dashboard - Traces of Adhesive Tape - Yes</p> | <p><b>Remarks</b><br/>(R) Front Door - Repair Traces - Yes / Bonnet - Repair Traces - Yes / (L) Front Door - Repair Traces - Yes / (L) Rear Fender - Repair Traces - Yes / Trunk Hood, Rear Gate - Repair Traces - Yes / (R) Rear Fender - Repair Traces - Yes / (R) Rear Door - Repair Traces - Yes / Roof - Repair Traces - Yes / (R) Front Door, Molding - Repair mark - Yes / (R) Rear Door, Molding - Repair mark - Yes / (R) Rear Fender, Molding - Repair mark - Yes / (L) Rear Door, Molding - Repair mark - Yes / (L) Rear Fender, Molding - Repair mark - Yes / Bonnet, Headlight - Scratch &amp; Dent - Medium / Front Bumper, Grille, Lamps - Crack, Gap - Large / (R) Front Fender, Molding - Scratch - Minimal / (R) Front Door, Molding - Scratch - Minimal / Rear Bumper, Lamps, Panels - Scratch - Medium / (L) Front Door, Molding - Scratch - Minimal / Roof - Scratch - Minimal / Trunk Hood, Rear Gate - Scratch - Small / (R) Rear Door, Molding - Scratch - Small / (R) Rear Fender, Molding - Scratch - Small / (L) Front Fender, Molding - Scratch - Small</p> |

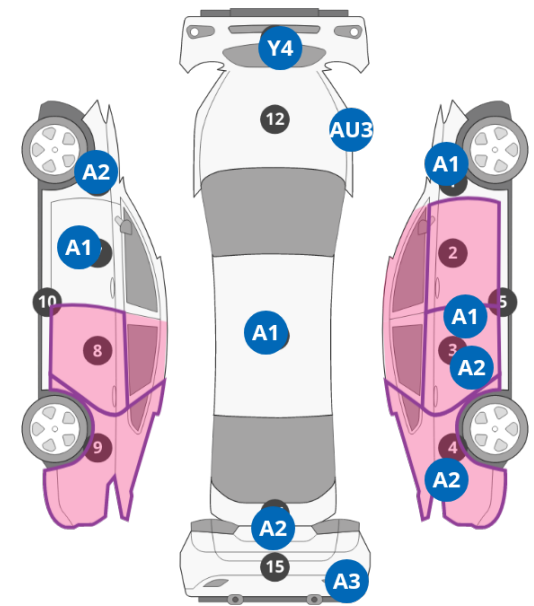
| <p>with warranty booklet and Jack,Sparetire. no Tools and LTO plate. scratch crack on headlight. towhook cover ,Missing</p> |
