## General Information

| Make | Toyota | Model | Hilux |
| Registration No. | BAF9270 | Chassis No. | MR0JB8DD3P3550412 |

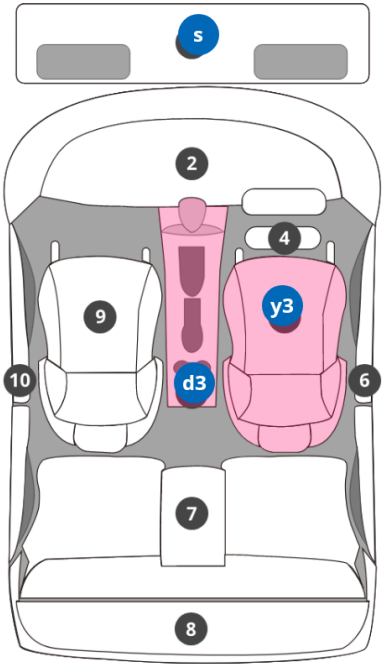
| <b>Interior Evaluation :</b> <b>B</b> | <b>Exterior Evaluation :</b> <b>B</b> |
| <b>Remarks</b><br>Console, Switchs, Vents - Loose, Deformed, Grime - Medium / Overall Interior - Smell - Yes / (R) Front Seat - Grime - Medium | <b>Remarks</b><br>Front Bumper, Grille, Lamps - Scratch - Medium / (L) Front Door, Molding - Scratch - Minimal / (L) Side Gate - Scratch - Small / Rear Gate - Scratch - Medium / Rear Bumper, Lamps, Panels - Scratch - Small / (R) Side Gate - Dent - Minimal / (R) Rear Door, Molding - Scratch - Minimal / (R) Front Door, Molding - Scratch & Dent - Minimal / (L) Mirror - Scratch - Minimal / Roof - Dent - Minimal |

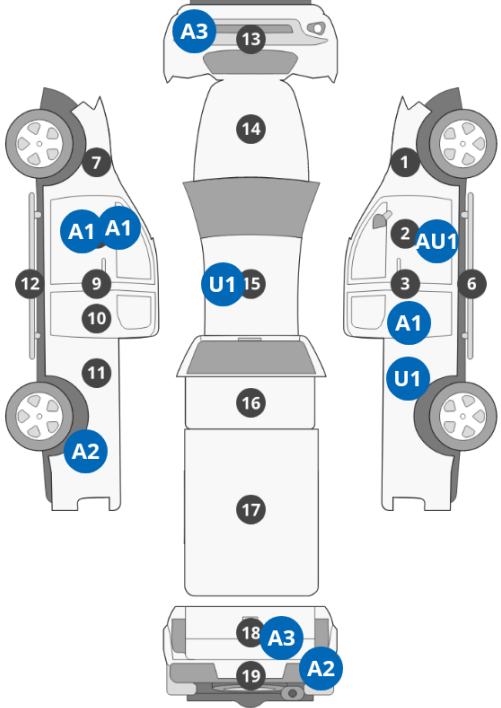
| swirl marks and hairline scratches around the exterior. aftermarket mattings. door handle covers. headlight and taillight covers.2 |
