General Information

Make	Toyota	Model	Vios
YOM	2023	Odo Meter Reading	52,679
Registration No.	CBI7428	Chassis No.	PA1B18F30P4218470
CC	1.3	Transmission	M/T
Fuel Type	Gas	Type of Body	Sedan
Colour	Black

Body / Panel Condition

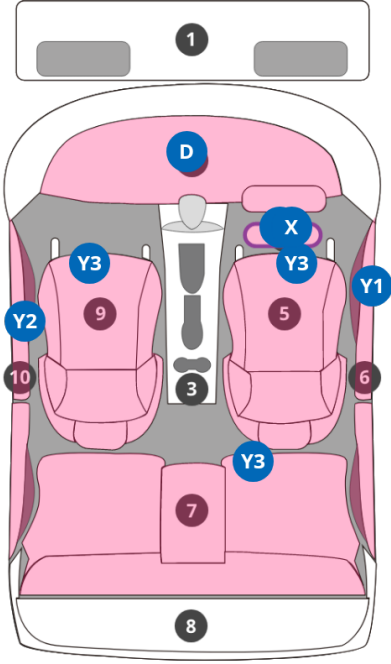
Interior Evaluation : B	Exterior Evaluation : E

<p>a : Cut, Fray d : Loose, Deformed k : Animal Hair s : Smell t : Cigarette Burns x : Defective y : Stain</p>

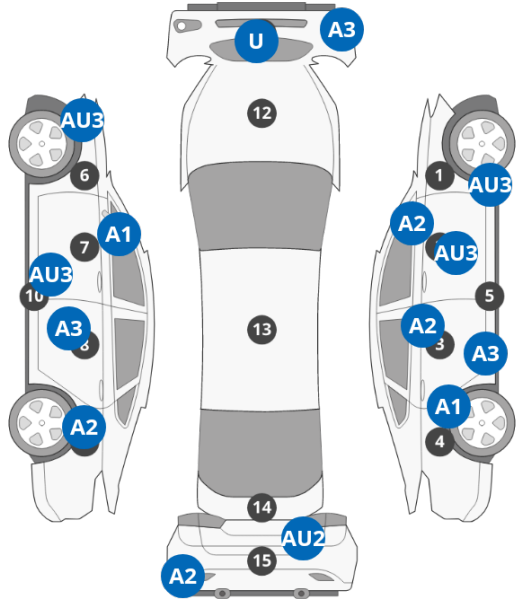
<p>A : Scratch AU : Scratch & Dent B : Modified C : Corrosion G : Stone chip P : Faded S : Rust SC : Rust & Corrosion U : Dent X : Defective Y : Crack, Gap</p>
<p>Remarks (R) Front Seat - Grime - Medium / (L) Front Seat - Grime - Medium / Rear Seat - Grime - Medium / (R) Front Trim - Grime - Minimal / (L) Front Trim - Grime - Small / Mat Other - Missing - Yes / (L) Front Floor Mat - Missing - Yes / Dashboard - Traces of Adhesive Tape - Yes</p>	<p>Remarks (R) Front Fender, Molding - Scratch & Dent - Medium / (R) Front Door, Molding - Scratch & Dent - Medium / (R) Step, In-panel, Side Spoiler - Scratch - Medium / (R) Rear Door, Molding - Scratch - Small / (R) Mirror - Scratch - Small / (R) Rear Fender, Molding - Scratch - Minimal / Rear Bumper, Lamps, Panels - Scratch - Small / Trunk Hood, Rear Gate - Scratch & Dent - Small / (L) Rear Fender, Molding - Scratch - Small / (L) Rear Door, Molding - Scratch - Medium / (L) Front Door, Molding - Scratch & Dent - Medium / (L) Mirror - Scratch - Minimal / (L) Front Fender, Molding - Scratch & Dent - Medium / Member (Bolted) - Dent - Yes / Front Bumper, Grille, Lamps - Scratch - Medium</p>
