General Information

Make	Toyota	Model	Innova
YOM	2023	Odo Meter Reading	65,428
Registration No.	NHI8907	Chassis No.	PA2JA8EMXP0123682
CC	2.8	Transmission	A/T
Fuel Type	Diesel	Type of Body	Wagon
Colour	Silver

Body / Panel Condition

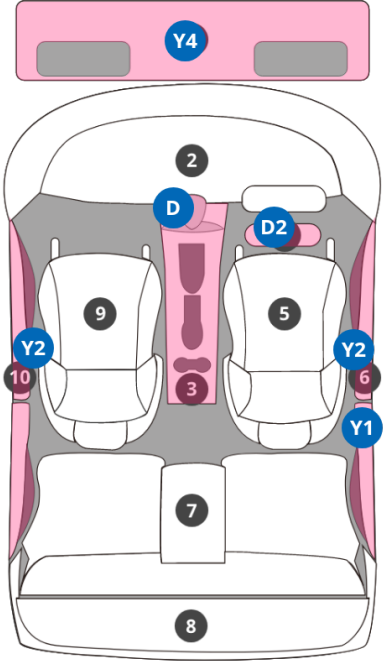
Interior Evaluation : C	Exterior Evaluation : C

<p>a : Cut, Fray d : Loose, Deformed k : Animal Hair s : Smell t : Cigarette Burns x : Defective y : Stain</p>

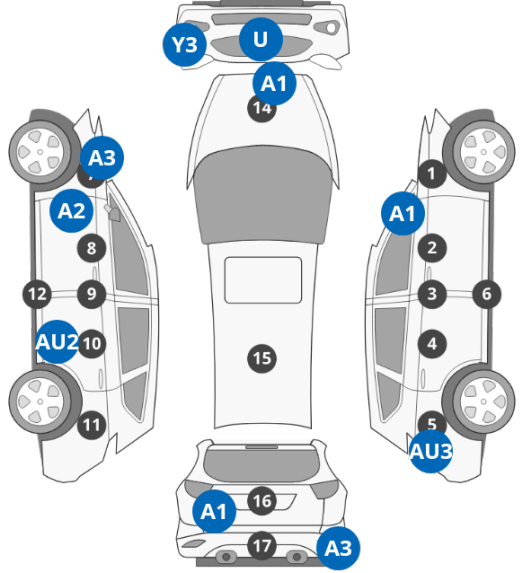
<p>A : Scratch AU : Scratch & Dent B : Modified C : Corrosion G : Stone chip P : Faded S : Rust SC : Rust & Corrosion U : Dent X : Defective Y : Crack, Gap</p>
<p>Remarks (R) Rear Trim - Grime - Minimal / (R) Front Trim - Grime - Small / (L) Front Floor Mat - Worked - Small / (L) Front Trim - Grime - Small / Console, Switchs, Vents - Traces of Adhesive Tape - Yes / Ceiling - Grime - Large</p>	<p>Remarks Member (Bolted) - Dent - Yes / (R) Mirror - Scratch - Minimal / (R) Rear Fender, Molding - Scratch & Dent - Medium / Rear Bumper, Lamps, Panels - Scratch - Medium / (L) Rear Door, Molding - Scratch & Dent - Small / (L) Front Door, Molding - Scratch - Small / (L) Front Fender, Molding - Scratch - Medium / Front Bumper, Grille, Lamps - Crack, Gap - Medium / Bonnet, Headlight - Scratch - Minimal / Trunk Hood, Rear Gate - Scratch - Minimal</p>
