General Information

Make	Toyota	Model	Vios
YOM	2025	Odo Meter Reading	18,747
Registration No.	NKF2095	Chassis No.	PA1B18F34R4268968
CC	1.3	Transmission	CVT
Fuel Type	Gas	Type of Body	Sedan
Colour	Blue

Body / Panel Condition

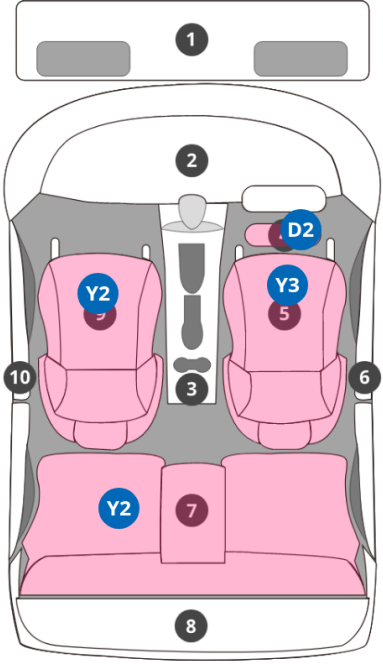
Interior Evaluation : B	Exterior Evaluation : D

<p>a : Cut, Fray d : Loose, Deformed k : Animal Hair s : Smell t : Cigarette Burns x : Defective y : Stain</p>

<p>A : Scratch AU : Scratch & Dent B : Modified C : Corrosion G : Stone chip P : Faded S : Rust SC : Rust & Corrosion U : Dent X : Defective Y : Crack, Gap</p>
<p>Remarks Rear Seat - Grime - Small / (L) Front Seat - Grime - Small / (L) Front Floor Mat - Worked - Small / (R) Front Seat - Grime - Medium</p>	<p>Remarks (R) Rear Door, Molding - Scratch & Dent - Large / (R) Front Door, Molding - Scratch - Large / (R) Rear Fender, Molding - Scratch - Small / Bonnet, Headlight - Repair mark - Yes / Bonnet, Headlight - Scratch - Minimal / (L) Front Door, Molding - Scratch - Small / (L) Rear Door, Molding - Scratch & Dent - Large / (L) Rear Fender, Molding - Scratch - Minimal / (L) Front Fender, Molding - Crack, Gap - Medium / Rear Bumper, Lamps, Panels - Scratch - Small / Roof - Scratch - Minimal / Front Bumper, Grille, Lamps - Scratch - Small / Trunk Hood, Rear Gate - Scratch - Minimal</p>

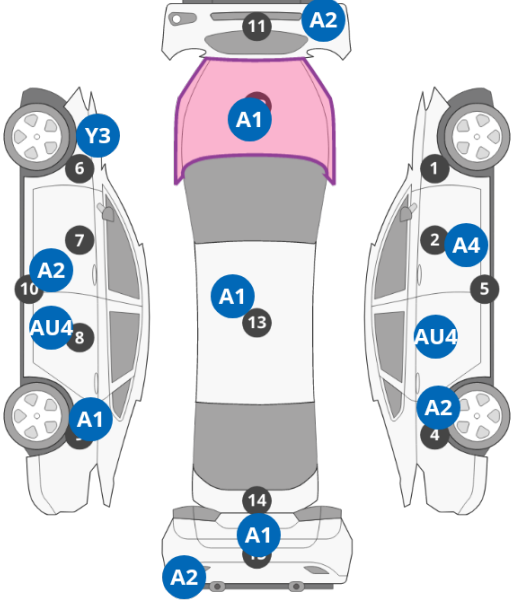
<p>Inspector Notes</p>
<p>with warranty booklet and LTO plate and Jack, Sparetire and Tools. scratch headlight and tail light.</p>
