General Information

Make	Toyota	Model	Vios
YOM	2023	Odo Meter Reading	26,740
Registration No.	CBK9799	Chassis No.	PA1B18F35P4220229
CC	1.3	Transmission	CVT
Fuel Type	Gas	Type of Body	Sedan
Colour	Green

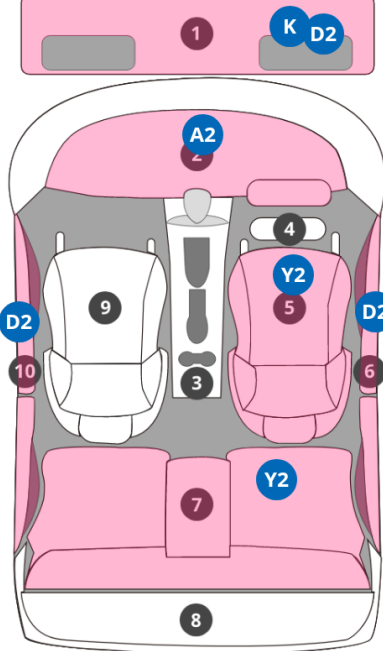
<p>a : Cut, Fray d : Loose, Deformed k : Animal Hair s : Smell t : Cigarette Burns x : Defective y : Stain</p>

<p>A : Scratch AU : Scratch & Dent B : Modified C : Corrosion G : Stone chip P : Faded S : Rust SC : Rust & Corrosion U : Dent X : Defective Y : Crack, Gap</p>
<p>Remarks Overall Interior - Worn as per age - Yes / Overall Interior - Animal Hair - Yes / Ceiling - Crinkle - Small / (R) Front Seat - Grime - Small / Rear Seat - Grime - Small / Dashboard - Worn, Scratch, Cut, Crack - Small / (L) Front Trim - Worked - Small / (R) Front Trim - Worked - Small</p>	<p>Remarks (L) Front Fender, Molding - Scratch - Small / (L) Step, In-panel, Side Spoiler - Scratch & Dent - Medium / (L) Rear Door, Molding - Scratch & Dent - Small / (L) Rear Fender, Molding - Scratch & Dent - Small / (R) Rear Fender, Molding - Scratch - Small / Rear Bumper, Lamps, Panels - Scratch - Small / (R) Rear Door, Molding - Scratch - Medium / Front Bumper, Grille, Lamps - Scratch - Small / (R) Front Door, Molding - Scratch & Dent - Small / Roof - Scratch - Small / Bonnet, Headlight - Crack, Gap - Large / (R) Front Fender, Molding - Scratch & Dent - Medium</p>

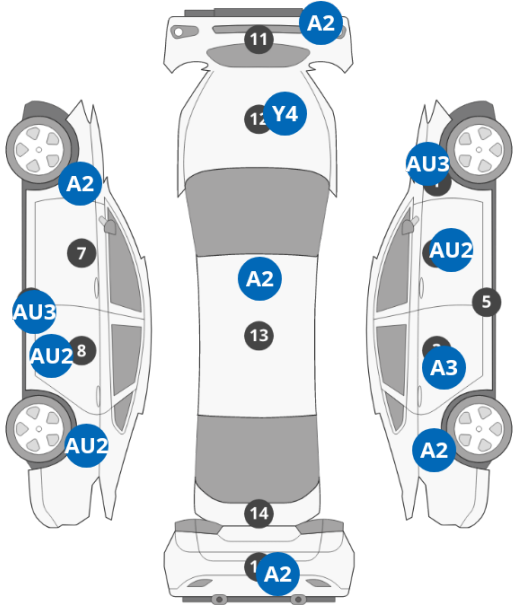
<p>Inspector Notes</p>
<p>with sparetire and incomplete tools.no warranty booklet and LTO plate, scratches on tail lights and head lights. adhesive mark on rear left side door trim inside.</p>
