General Information

Make	Toyota	Model	Vios
YOM	2024	Odo Meter Reading	13,351
Registration No.	DBN9646-1	Chassis No.	PA1B18F37P4237761
CC	1.3	Transmission	CVT
Fuel Type	Gas	Type of Body	Sedan
Colour	Green

Body / Panel Condition

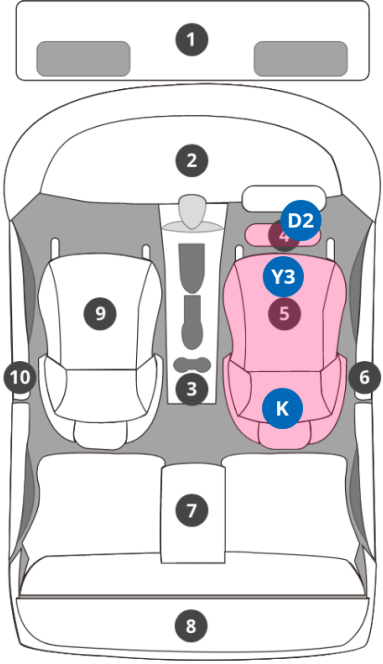
Interior Evaluation : B	Exterior Evaluation : C

<p>a : Cut, Fray d : Loose, Deformed k : Animal Hair s : Smell t : Cigarette Burns x : Defective y : Stain</p>

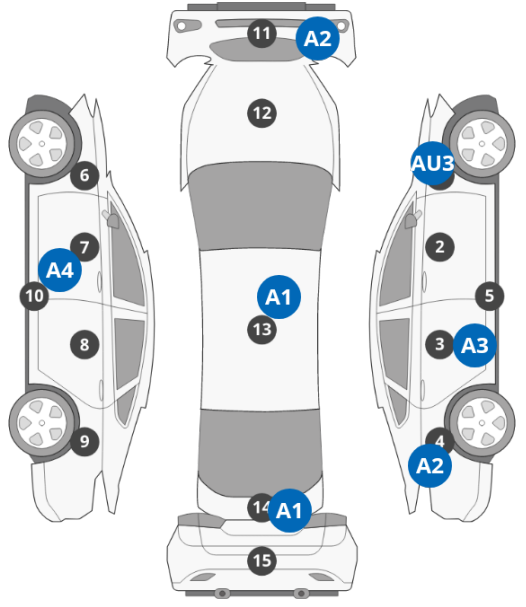
<p>A : Scratch AU : Scratch & Dent B : Modified C : Corrosion G : Stone chip P : Faded S : Rust SC : Rust & Corrosion U : Dent X : Defective Y : Crack, Gap</p>
Remarks Overall Interior - Animal Hair - Yes / (R) Front Seat - Grime - Medium / (L) Front Floor Mat - Worked - Small	Remarks Front Bumper, Grille, Lamps - Scratch - Small / (R) Front Fender, Molding - Scratch & Dent - Medium / (R) Rear Door, Molding - Scratch - Medium / (R) Rear Fender, Molding - Scratch - Small / Trunk Hood, Rear Gate - Scratch - Minimal / (L) Front Door, Molding - Scratch - Large / Roof - Scratch - Minimal
Frame Evaluation : A	Functional Evaluation : A
Remarks Defects not found	Remarks Defects not found
