## General Information

<b>Make</b>	Toyota	<b>Model</b>	Vios
<b>YOM</b>	2024	<b>Odo Meter Reading</b>	9,935
<b>Registration No.</b>	NHQ6164	<b>Chassis No.</b>	PA1B18F31R4251531
<b>CC</b>	1.3	<b>Transmission</b>	CVT
<b>Fuel Type</b>	Gas	<b>Type of Body</b>	Sedan
<b>Colour</b>	Blue

## Body / Panel Condition

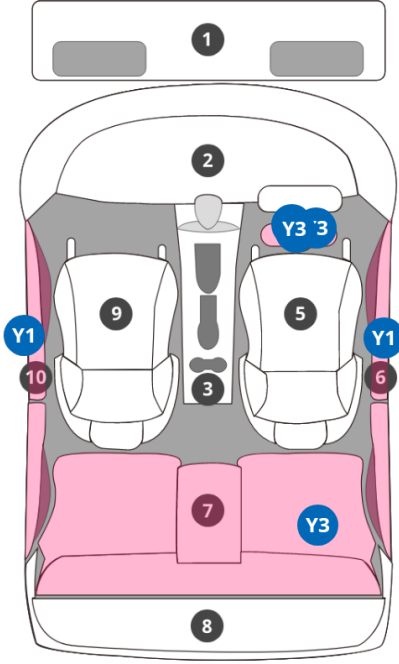
<b>Interior Evaluation :</b> <span style="float: right; color: red; font-weight: bold;">C</span>	<b>Exterior Evaluation :</b> <span style="float: right; color: red; font-weight: bold;">C</span>

<p><b>a</b> : Cut, Fray <b>d</b> : Loose, Deformed <b>k</b> : Animal Hair <b>s</b> : Smell <b>t</b> : Cigarette Burns <b>x</b> : Defective <b>y</b> : Stain</p>

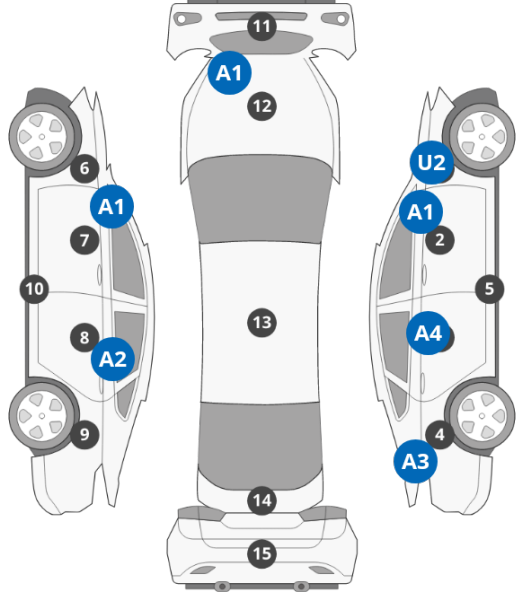
<p><b>A</b> : Scratch <b>AU</b> : Scratch &amp; Dent <b>B</b> : Modified <b>C</b> : Corrosion <b>G</b> : Stone chip <b>P</b> : Faded <b>S</b> : Rust <b>SC</b> : Rust &amp; Corrosion <b>U</b> : Dent <b>X</b> : Defective <b>Y</b> : Crack, Gap</p>
<p><b>Remarks</b> Mat Other - Grime - Medium / Rear Seat - Grime - Medium / (R) Front Trim - Grime - Minimal / (R) Front Floor Mat - Grime - Medium / (L) Rear Trim - Grime - Minimal / (L) Front Floor Mat - Worked - Small / (L) Front Floor Mat - Grime - Medium</p>	<p><b>Remarks</b> (R) Front Fender, Molding - Dent - Small / (R) Mirror - Scratch - Minimal / (R) Rear Door, Molding - Scratch - Large / (R) Rear Fender, Molding - Scratch - Medium / (L) Rear Door, Molding - Scratch - Small / (L) Mirror - Scratch - Minimal / Bonnet, Headlight - Scratch - Minimal</p>
