General Information

Make	Toyota	Model	Vios
YOM	2024	Odo Meter Reading	11,314
Registration No.	DBF7102	Chassis No.	PA1B18F35R4250527
CC	1.3	Transmission	CVT
Fuel Type	Gas	Type of Body	Sedan
Colour	Red

Body / Panel Condition

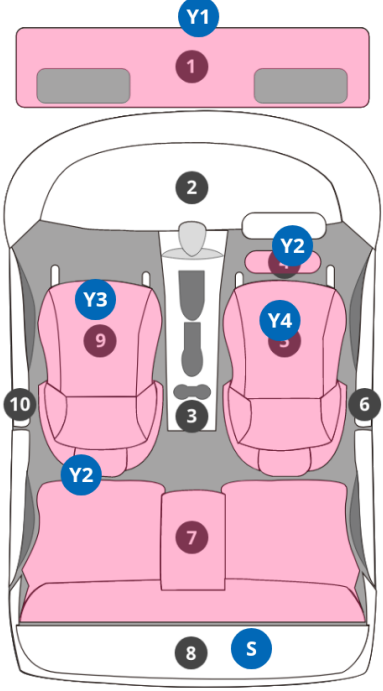
Interior Evaluation : C	Exterior Evaluation : E

<p>a : Cut, Fray d : Loose, Deformed k : Animal Hair s : Smell t : Cigarette Burns x : Defective y : Stain</p>

<p>A : Scratch AU : Scratch & Dent B : Modified C : Corrosion G : Stone chip P : Faded S : Rust SC : Rust & Corrosion U : Dent X : Defective Y : Crack, Gap</p>
<p>Remarks (R) Front Seat - Grime - Large / (R) Front Floor Mat - Grime - Small / Rear Seat - Grime - Small / (L) Front Seat - Grime - Medium / Ceiling - Grime - Minimal / Overall Interior - Smell - Yes</p>	<p>Remarks (L) Front Fender, Molding - Scratch & Dent - Large / (L) Front Door, Molding - Scratch & Dent - Medium / Front Bumper, Grille, Lamps - Scratch - Large / (R) Front Fender, Molding - Scratch - Small / (R) Mirror - Scratch - Small / (R) Rear Door, Molding - Scratch - Small / (R) Front Door, Molding - Scratch - Small / (R) Rear Fender, Molding - Scratch - Small / Rear Bumper, Lamps, Panels - Scratch - Medium / (L) Rear Fender, Molding - Scratch - Medium / Trunk Hood, Rear Gate - Scratch - Medium / (L) Rear Door, Molding - Scratch - Small / Roof - Scratch - Small / Bonnet, Headlight - Scratch & Dent - Medium</p>

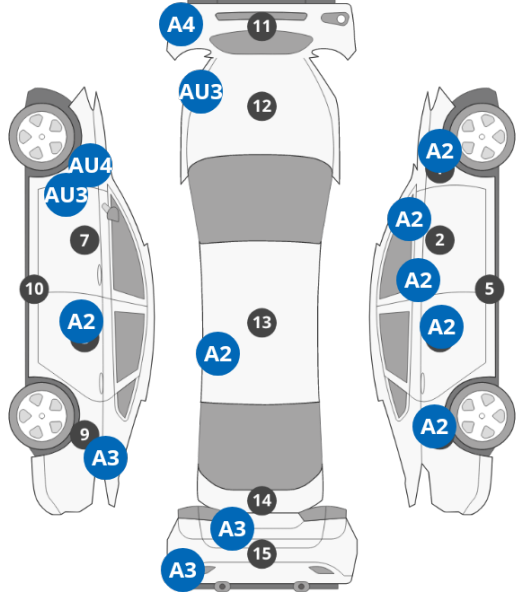
<p>Inspector Notes</p>
<p>with LTO plate, with warranty booklet, with jack, trunk door not opening, left cheek light missing, bent front left wheel, left front door not opening fully, cracked headlights, tail light scratches</p>
