General Information

Make	Toyota	Model	Vios
YOM	2025	Odo Meter Reading	19,716
Registration No.	DBP6713	Chassis No.	PA1B18F39R4264592
CC	1.3	Transmission	CVT
Fuel Type	Gas	Type of Body	Sedan
Colour	Red

Body / Panel Condition

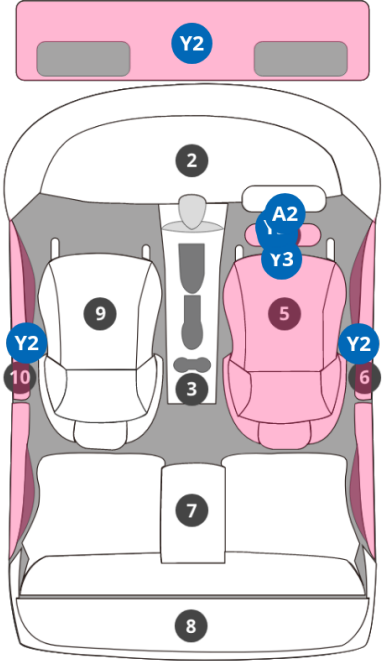
<p>a : Cut, Fray d : Loose, Deformed k : Animal Hair s : Smell t : Cigarette Burns x : Defective y : Stain</p>

<p>A : Scratch AU : Scratch & Dent B : Modified C : Corrosion G : Stone chip P : Faded S : Rust SC : Rust & Corrosion U : Dent X : Defective Y : Crack, Gap</p>
<p>Remarks (R) Front Seat - Grime - Medium / (L) Front Floor Mat - Worked - Large / (R) Front Floor Mat - Grime - Medium / (R) Front Trim - Grime - Small / (L) Front Trim - Grime - Small / (L) Front Floor Mat - Cut, Crack - Small / Ceiling - Grime - Small</p>	<p>Remarks (R) Rear Door, Molding - Scratch - Large / (R) Step, In-panel, Side Spoiler - Scratch & Dent - Large / (R) Rear Fender, Molding - Scratch - Medium / Trunk Hood, Rear Gate - Scratch - Minimal / (L) Rear Door, Molding - Scratch & Dent - Small / (L) Front Door, Molding - Scratch - Small / (L) Front Fender, Molding - Scratch - Medium / Front Bumper, Grille, Lamps - Scratch & Dent - Large / Roof - Scratch - Small / (R) Front Door, Molding - Scratch & Dent - Minimal / (R) Front Fender, Molding - Scratch - Minimal</p>

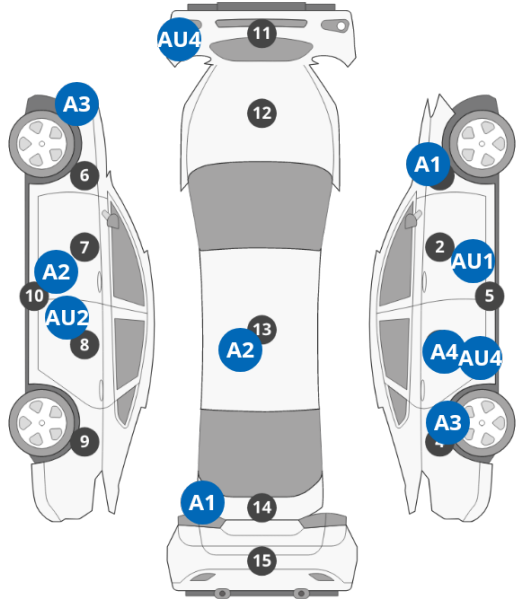
<p>Inspector Notes</p>
<p>with warranty booklet, with jack, incomplete tools, with spare tire, with LTO plate, scratches on tail light</p>
