## General Information

<b>Make</b>	Toyota	<b>Model</b>	Raize
<b>YOM</b>	2025	<b>Odo Meter Reading</b>	10,286
<b>Registration No.</b>	DBQ7286	<b>Chassis No.</b>	MHKAB1BAXRJ10038
<b>CC</b>	1.2	<b>Transmission</b>	CVT
<b>Fuel Type</b>	Gas	<b>Type of Body</b>	SUV
<b>Colour</b>	Gray

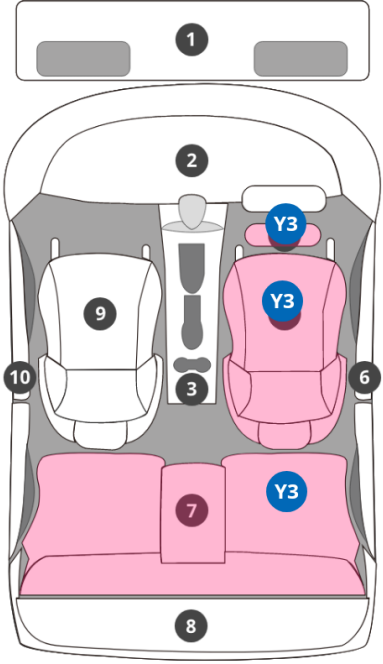
<p><b>a</b> : Cut, Fray <b>d</b> : Loose, Deformed <b>k</b> : Animal Hair <b>s</b> : Smell <b>t</b> : Cigarette Burns <b>x</b> : Defective <b>y</b> : Stain</p>

<p><b>A</b> : Scratch <b>AU</b> : Scratch &amp; Dent <b>B</b> : Modified <b>C</b> : Corrosion <b>G</b> : Stone chip <b>P</b> : Faded <b>S</b> : Rust <b>SC</b> : Rust &amp; Corrosion <b>U</b> : Dent <b>X</b> : Defective <b>Y</b> : Crack, Gap</p>
<p><b>Remarks</b> Rear Seat - Grime - Medium / (R) Front Seat - Grime - Medium / (L) Front Floor Mat - Grime - Medium</p>	<p><b>Remarks</b> (R) Front Door, Molding - Scratch - Medium / Rear Bumper, Lamps, Panels - Scratch - Small / (L) Rear Door, Molding - Scratch - Small / Member (Bolted) - Dent - Yes / Front Bumper, Grille, Lamps - Repair mark - Difference in Color / Front Bumper, Grille, Lamps - Scratch - Small / Roof - Scratch - Small</p>
