## General Information

| Make | Toyota | Model | Vios |

## Body / Panel Condition

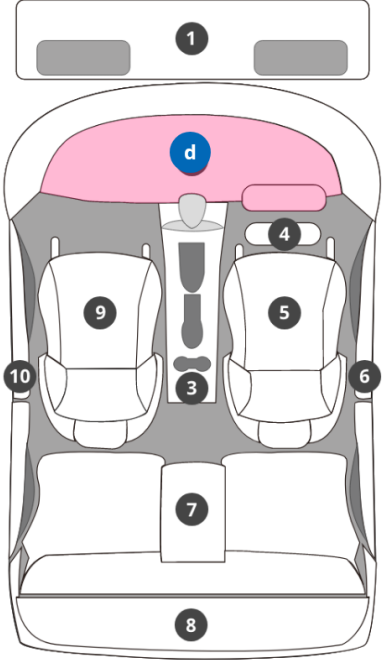
| <b>Interior Evaluation :</b> <span style="color: red; font-weight: bold;">A</span> | <b>Exterior Evaluation :</b> <span style="color: red; font-weight: bold;">C</span> |
| <b>Remarks</b><br>Dashboard - Traces of Adhesive Tape - Yes | <b>Remarks</b><br>Rear End Panel - Repair Traces - Yes / Trunk Hood, Rear Gate - Scratch & Dent - Large / Rear Bumper, Lamps, Panels - Scratch & Dent - Large / (L) Step, In-panel, Side Spoiler - Scratch - Small / (L) Rear Fender, Molding - Scratch & Dent - Medium / (R) Rear Fender, Molding - Scratch & Dent - Medium / (L) Rear Door, Molding - Scratch - Small / (L) Front Door, Molding - Scratch - Small / (R) Rear Door, Molding - Scratch - Minimal |

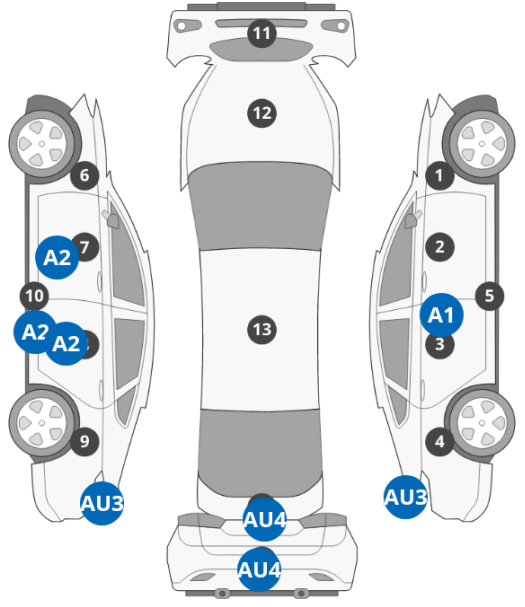
| Inspector Notes |
|---|
| tail lights are broken/ trunk cannot be opened/ aftermarket floor mats/ bumper needs to be replaced/ rear parking sensor damage |
