General Information

Make	Toyota	Model	Vios
YOM	2024	Odo Meter Reading	24,987
Registration No.	NFF6113	Chassis No.	PA1B18F35R4240435
CC	1.3	Transmission	CVT
Fuel Type	Gas	Type of Body	Sedan
Colour	Blue

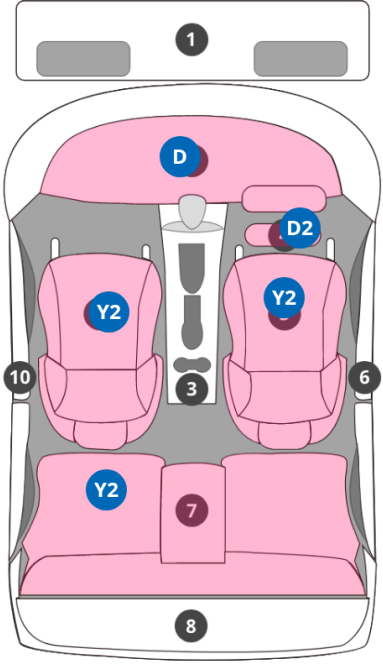
<p>a : Cut, Fray d : Loose, Deformed k : Animal Hair s : Smell t : Cigarette Burns x : Defective y : Stain</p>

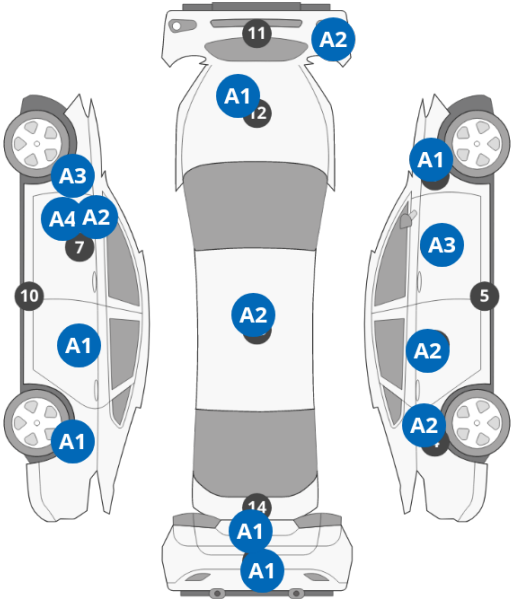
<p>A : Scratch AU : Scratch & Dent B : Modified C : Corrosion G : Stone chip P : Faded S : Rust SC : Rust & Corrosion U : Dent X : Defective Y : Crack, Gap</p>
<p>Remarks (L) Front Floor Mat - Worked - Small / (R) Front Seat - Grime - Small / (L) Front Seat - Grime - Small / Rear Seat - Grime - Small / Dashboard - Traces of Adhesive Tape - Yes</p>	<p>Remarks Rear Bumper, Lamps, Panels - Scratch - Minimal / (L) Front Door, Molding - Scratch - Large / (L) Front Fender, Molding - Scratch - Medium / (L) Mirror - Scratch - Small / Bonnet, Headlight - Scratch - Minimal / Front Bumper, Grille, Lamps - Scratch - Small / (R) Front Fender, Molding - Scratch - Minimal / (R) Front Door, Molding - Scratch - Medium / (R) Rear Door, Molding - Scratch - Small / (R) Rear Fender, Molding - Scratch - Small / Trunk Hood, Rear Gate - Scratch - Minimal / Roof - Scratch - Small / (L) Rear Fender, Molding - Scratch - Minimal / (L) Rear Door, Molding - Scratch - Minimal</p>
