General Information

Make	Toyota	Model	Vios
YOM	2022	Odo Meter Reading	44,409
Registration No.	NFG3959	Chassis No.	PA1B8F38M4164430
CC	1.3	Transmission	CVT
Fuel Type	Gas	Type of Body	Sedan
Colour	Red

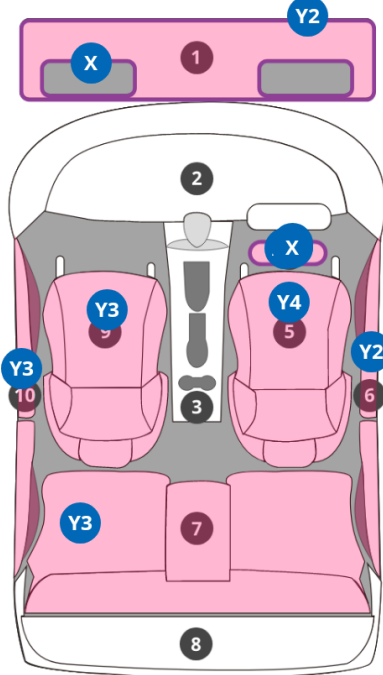
Interior Evaluation : C	Exterior Evaluation : E

<p>a : Cut, Fray d : Loose, Deformed k : Animal Hair s : Smell t : Cigarette Burns x : Defective y : Stain</p>

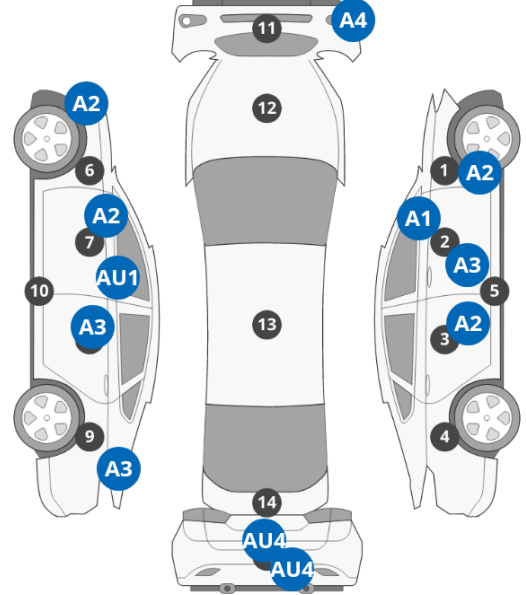
<p>A : Scratch AU : Scratch & Dent B : Modified C : Corrosion G : Stone chip P : Faded S : Rust SC : Rust & Corrosion U : Dent X : Defective Y : Crack, Gap</p>
<p>Remarks (R) Front Seat - Grime - Large / (L) Front Seat - Grime - Medium / Rear Seat - Grime - Medium / (R) Front Trim - Grime - Small / (L) Front Trim - Grime - Medium / (L) Front Floor Mat - Cut, Crack - Small / (L) Front Floor Mat - Worked - Small / (R) Front Floor Mat - Missing - Yes / Mat Other - Missing - Yes / Sunvisor, Sunglass Holder - Missing - Yes / Ceiling - Grime - Small</p>	<p>Remarks (R) Front Fender, Molding - Scratch - Small / (R) Mirror - Scratch - Minimal / (R) Front Door, Molding - Scratch - Medium / (R) Rear Door, Molding - Scratch - Small / Rear Bumper, Lamps, Panels - Scratch & Dent - Large / Trunk Hood, Rear Gate - Scratch & Dent - Large / (L) Rear Fender, Molding - Scratch - Medium / (L) Rear Door, Molding - Scratch - Medium / (L) Front Door, Molding - Scratch & Dent - Minimal / (L) Mirror - Scratch - Small / (L) Front Fender, Molding - Scratch - Small / Front Bumper, Grille, Lamps - Scratch - Large</p>
