General Information

Make	Toyota	Model	Raize
YOM	2024	Odo Meter Reading	5,004
Registration No.	NFR7454	Chassis No.	MHKAB1BA2RJ081705
CC	1.2	Transmission	CVT
Fuel Type	Gas	Type of Body	SUV
Colour	Red

Body / Panel Condition

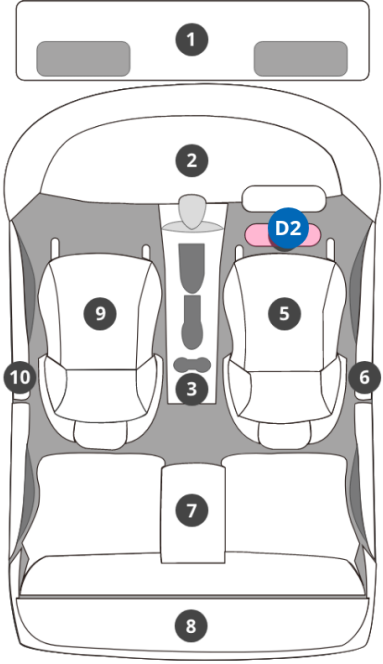
Interior Evaluation : A	Exterior Evaluation : A

<p>a : Cut, Fray d : Loose, Deformed k : Animal Hair s : Smell t : Cigarette Burns x : Defective y : Stain</p>

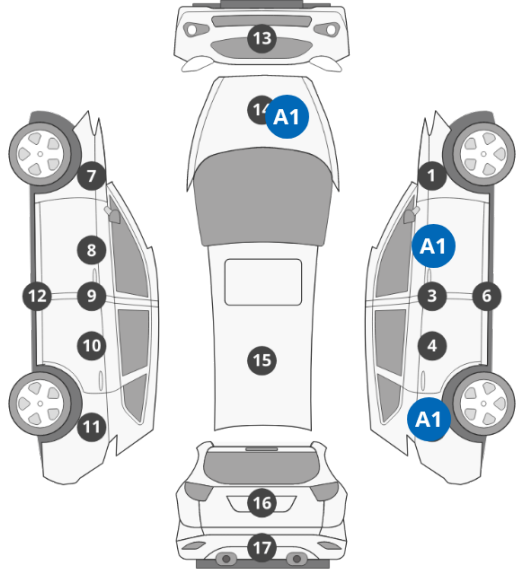
<p>A : Scratch AU : Scratch & Dent B : Modified C : Corrosion G : Stone chip P : Faded S : Rust SC : Rust & Corrosion U : Dent X : Defective Y : Crack, Gap</p>
Remarks (L) Front Floor Mat - Worked - Small	Remarks (R) Front Door, Molding - Scratch - Minimal / (R) Rear Fender, Molding - Scratch - Minimal / Bonnet, Headlight - Scratch - Minimal
Frame Evaluation : A	Functional Evaluation : A
Remarks Defects not found	Remarks Defects not found
